ESTONIAN ACADEMY OF ARTS
Faculty of Art and Culture
Department of Cultural Heritage and Conservation

**14TH CENTURY ENGLISH STAINED GLASS PANEL.
ANALYSIS OF THE GLASS DETERIORATION AND
CONSERVATION**

BACHELOR THESIS

Antwerp 2012

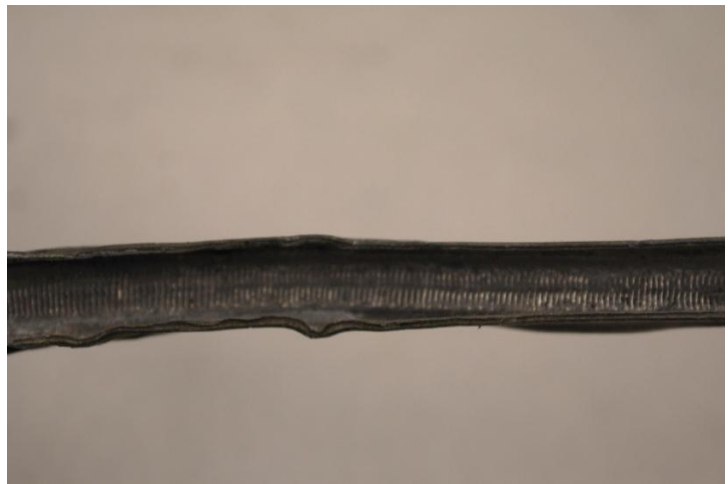
Observation of lead (Fig. 11.) shows that it has been made by milling and thus can not be medieval, which means that all the panel has been re-leaded. Only milled lead has marks of mill's teeth inside. The majority of British stained glass windows were restored and re-leaded during the 19th century.⁶⁵

Figure 11. Fragment of lead with signs of milling.

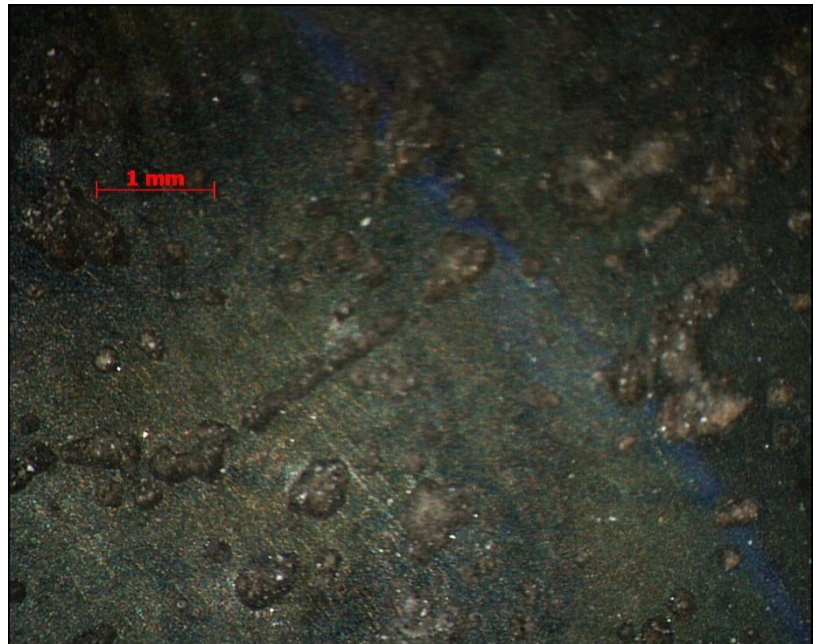
Microscopic studies. *Detorioration of surface layer.* Surface of the glass was examined under light microscope with direct and transmitted light. Under the microscope can be seen the extent of the deterioration, so the least damaging cleaning method can be chosen.

Figure 12. Deep pit corrosion 2,5x magnification.

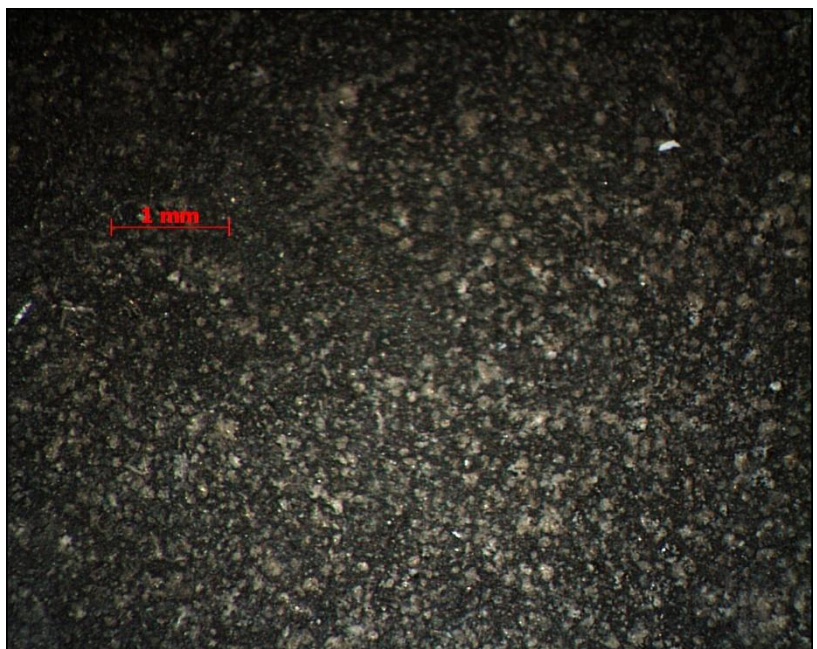
Figure 13. Closely placed pit corrosion that in transmitted light fog up the glass. 2,5x magnification.

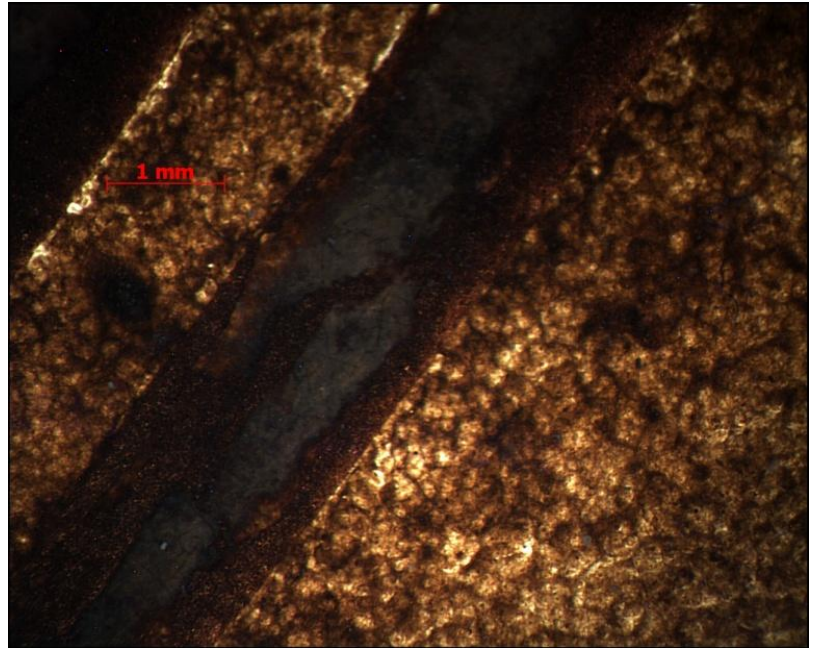
Microscopic studies. Possibility of Mn-staining. Surface of the glass was examined in a transmitted light and samples of the glass cross-section were taken to see if it has a Mn-staining. On the image of cross-section can be seen a deterioration layer and among it some halation that may refer to Mn-staining. Even though both, surface and cross-section, examination seem to be similar to Mn-staining, further research under SEM is needed.

Figure 14. Edge piece nr 7 with the signs of browning under transmitted light. 2,5x magnification.

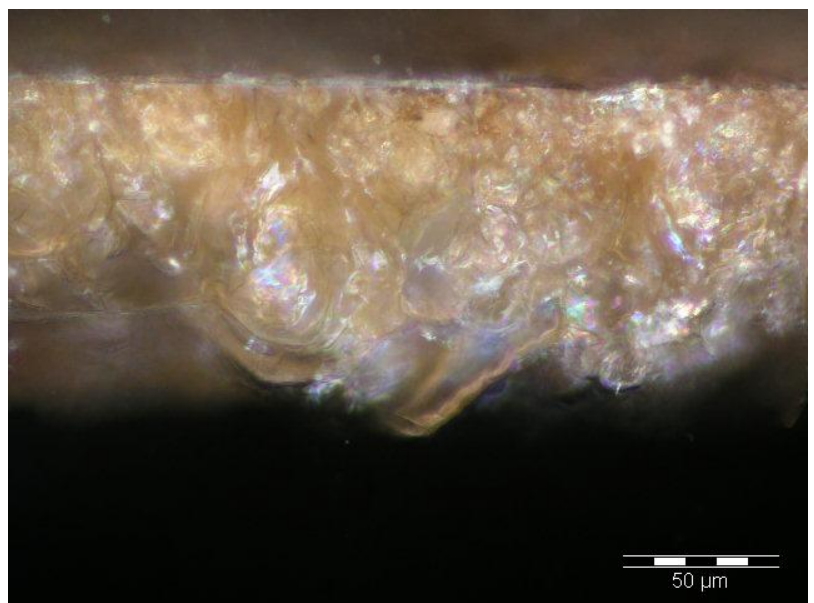
Figure 15. Cross-section of a piece nr 7, 500x magnification, dark field.

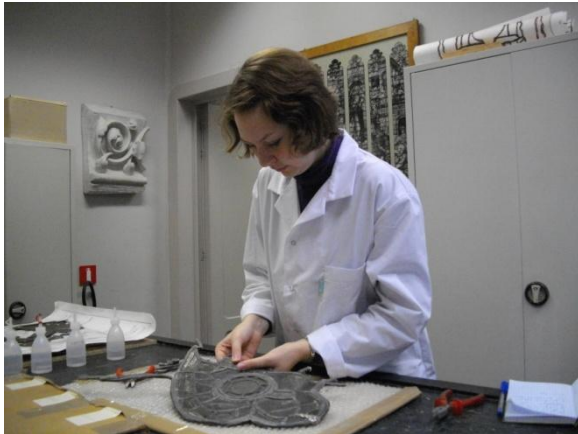
Dismantling (Fig. 16.) of the panel showed that it was cemented. One of the leads used to repair the piece nr 12 didn't have a core. Lead supporting crack in the piece nr 10 was heavily cemented to stay in place. After dismantling edges of the glass pieces can be seen that they show evident signs of use of the riesel iron (Fig. 17.).

Figure 16. Dismantling of the panel.

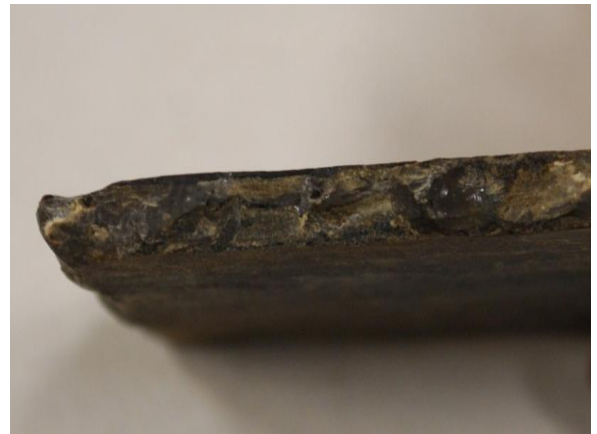
Figure 17. Grozed edge of the piece of glass.

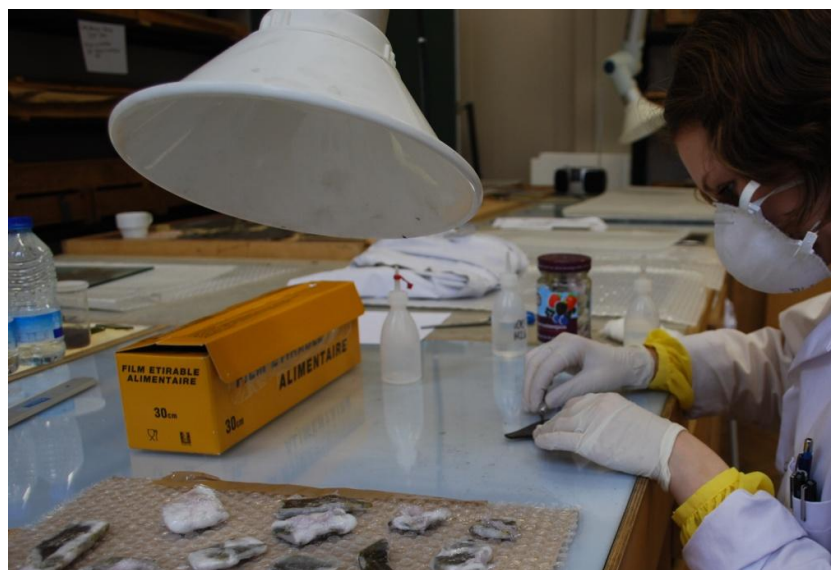
Figure 20. Removal of the cement.

The edges of the each piece were covered with cotton compress with DMF and wrapped in plastic to prevent the solution from evaporating. It was left like that for an hour to let the solution work (Fig 19.). After an hour the piece was taken out of the wrap and the softened cement was removed with a scalpel (Fig. 20.).

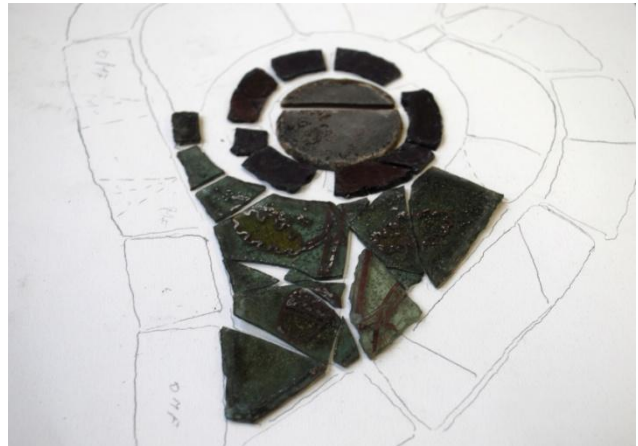
Figure 21. Planning the shape of the piece no. 12.

As a first step to **reconstruct the piece no. 12** was determined exact shape of the piece. It was done by combining all the fragments together and making a drawing on a paper (Fig. 21).

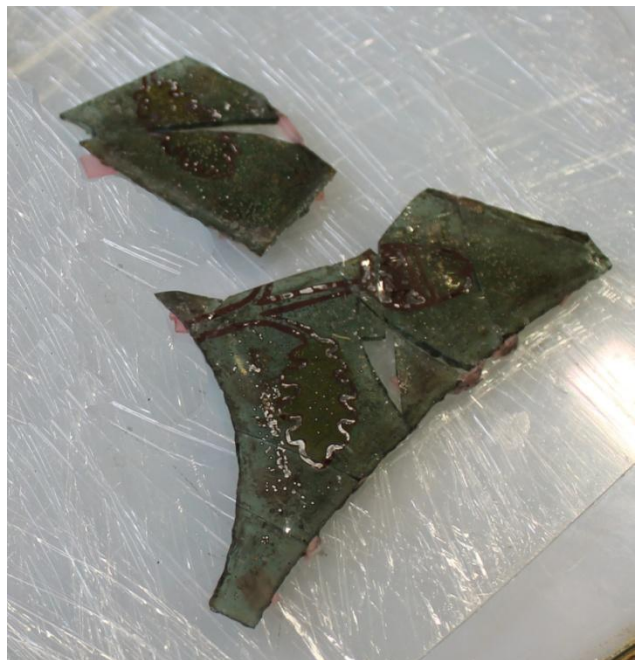
Figure 22. Bonding two sides of the piece.

Fragments of the left and right side of the piece were bonded with epoxy Araldite 2020, leaving out the fragment that had to be reconstructed. Smaller gaps were filled with the epoxy. (Fig 22.)

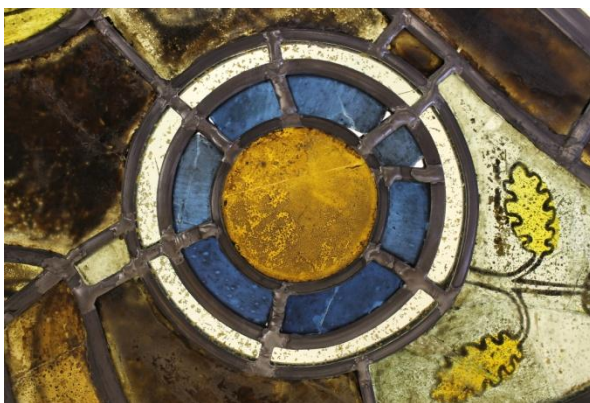
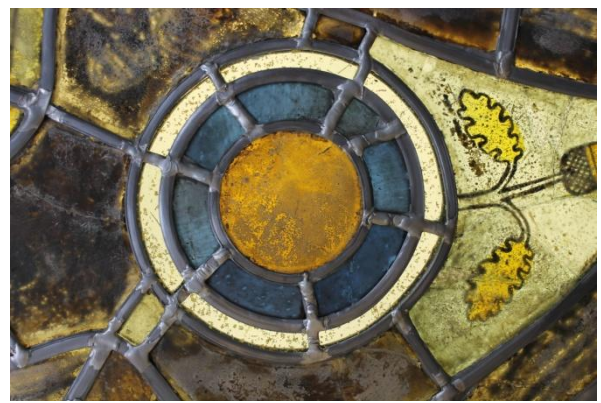
Figure 30. Detail of the panel before and after cementing.

After the panel was soldered it could be seen that there were still some gaps between the glass and the lead. To fill the gaps was used a cement. It was made by mixing powdered chalk and linen seed oil. In order to camouflage the cement and make it grey as lead, little amount of black pigment was added. Cement was applied with fingers as it gave the full control of the process and minimized the unnecessary impact with the panel. Leftovers of cement were removed with water ethanol 50/50 solution.

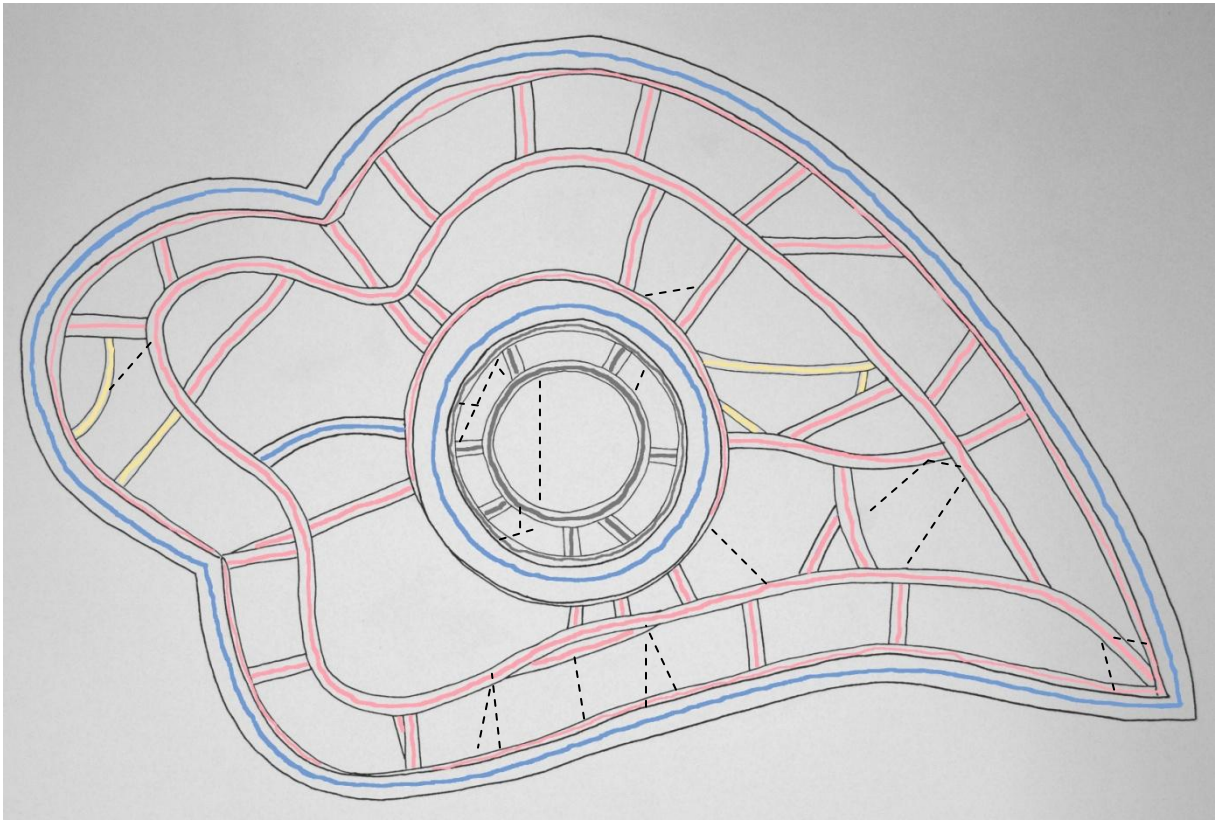
Figure 6. Documentation of different lead and cracks in the glass.

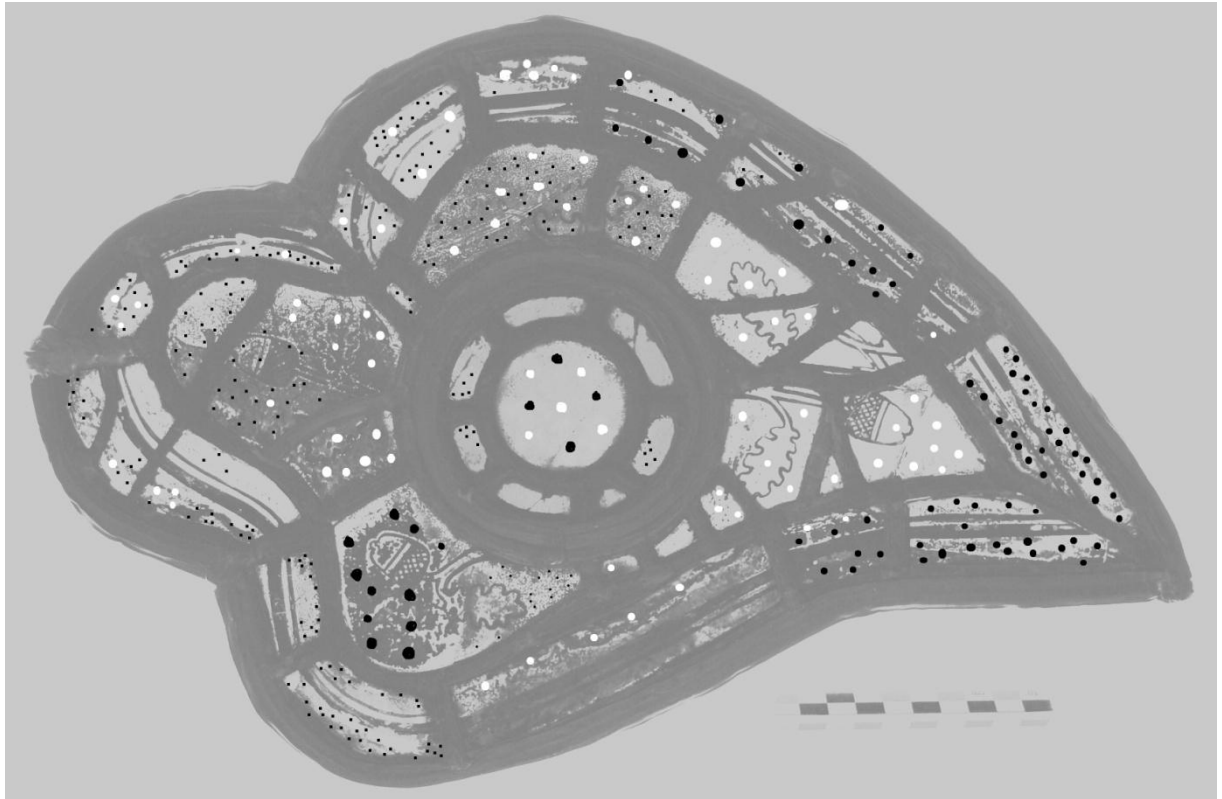
Figure 7. Documentation of deterioration. Front.

Deep craters of det.

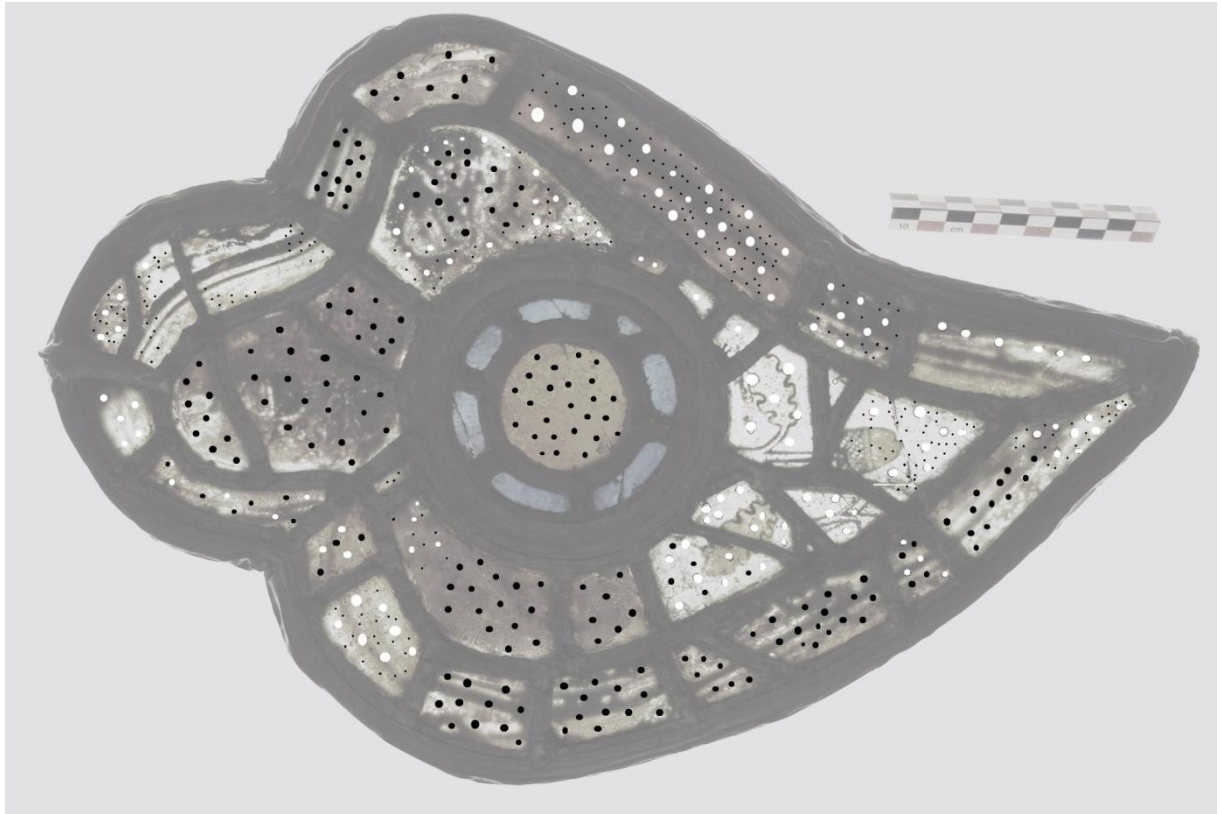
Figure 8. Documentation of deterioration. Back.

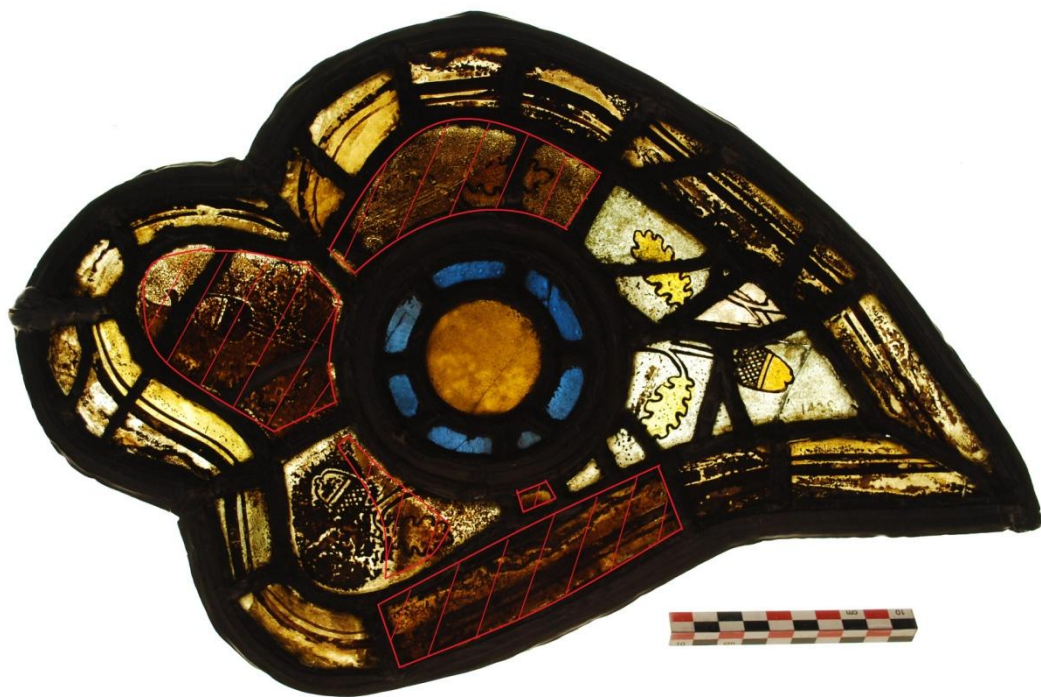
Figure 9. Documentation of possible Mn-staining location.

Possible location of Mn-staining
