ESTONIAN ACADEMY OF ARTS
Faculty of Art and Culture
Department of Cultural Heritage and Conservation

**The Design and Evaluation of Injection Grouts for the
Reattachment of Historic Plaster in St Mary's Church, Põide**

Master Thesis

Tallinn 2019

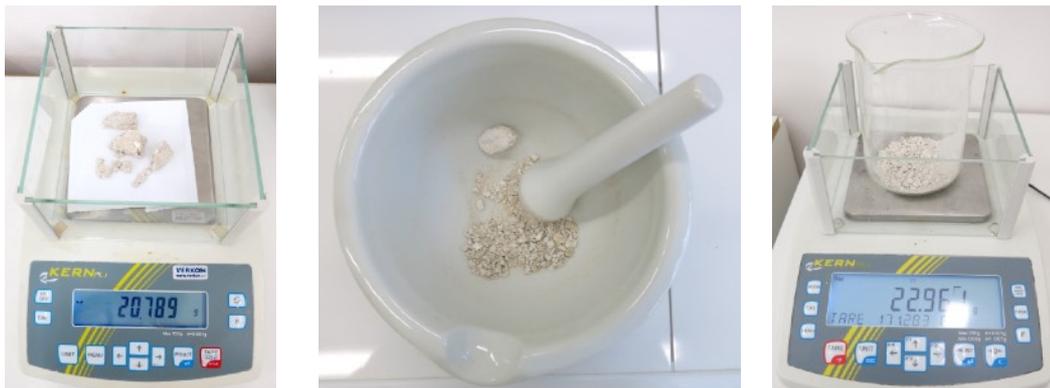
6. Weighting and grinding of historic plaster samples.

1. The historic plaster sampled were weighed.
2. Samples were crushed into smaller pieces with a pestle. Grinding had to be gentle to avoid crushing the aggregate into smaller pieces, since this would give inaccurate results in the grain size distribution of the sand (see ill. 6).

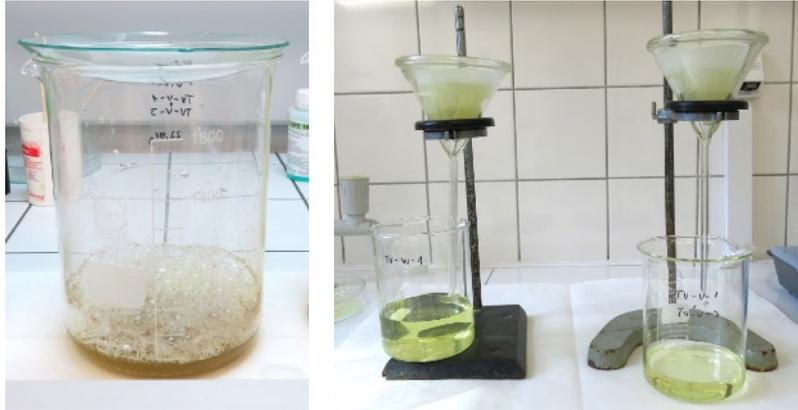
7. Crushed sample in hydrochloric acid and the filtration of the sand.

3. The crushed samples were put into a 600 ml glass container and weighed again.
4. The crushed samples were covered with a 35% concentration of hydrochloric acid (HCl) and left to react overnight.
5. After the acid had completely dissolved the calcium carbonate, the remaining sand was filtered out from the liquid and washed with distilled water repetitively until the wash water was clear (see ill. 7).

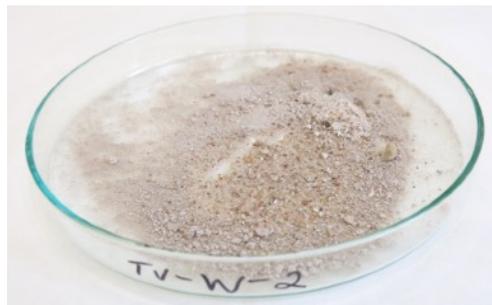
8. Dried sand on a petri dish.

6. After filtering, the filter paper together with the sand was placed on a petri dish and dried in the oven at 45°C for two hours.
7. The sand was carefully removed from the filter paper to document the weight of the dry sand (see ill. 8).

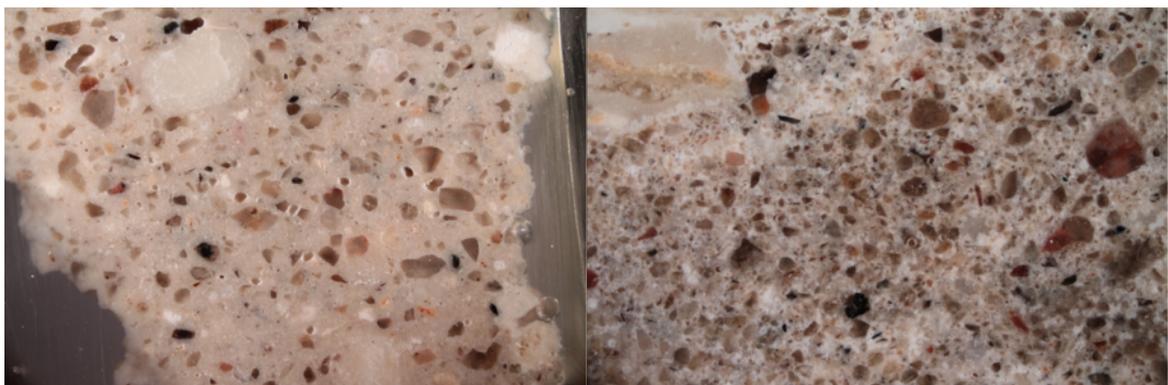
17. Gothic plaster from the vaulting panel (magnification: x 20). Designation of the sample is TV-V-3.

18. Gothic plaster from the lower part of the Northern wall (magnification: x 20). Designation of the sample is TV-W-1.

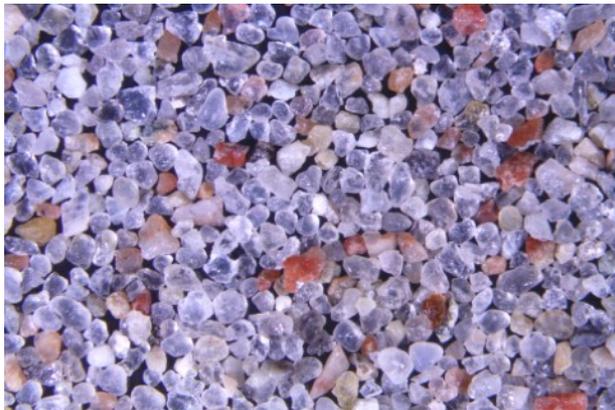
19. TV-V-1. Fraction of the sand is 0,25mm. Magnification: x10.

Fine particles of quartz (transparent/white) and granite (light red) sand can be seen in these optical microscope photographs, taken from the sand of both samples, TV-V-1 and TV-W-1 (see ill. 19 and 20).

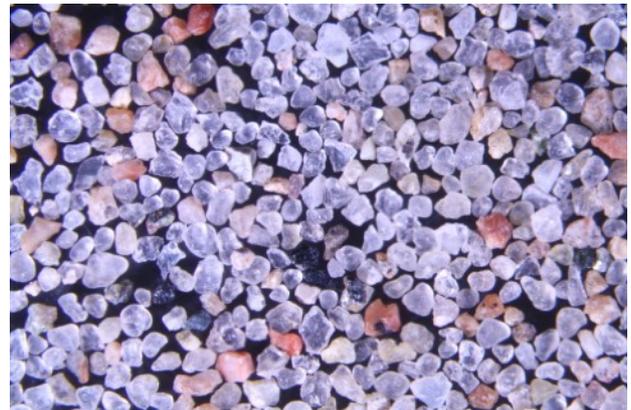
20. TV-W-1. Fraction of the sand is 0,25mm. Magnification: x10.

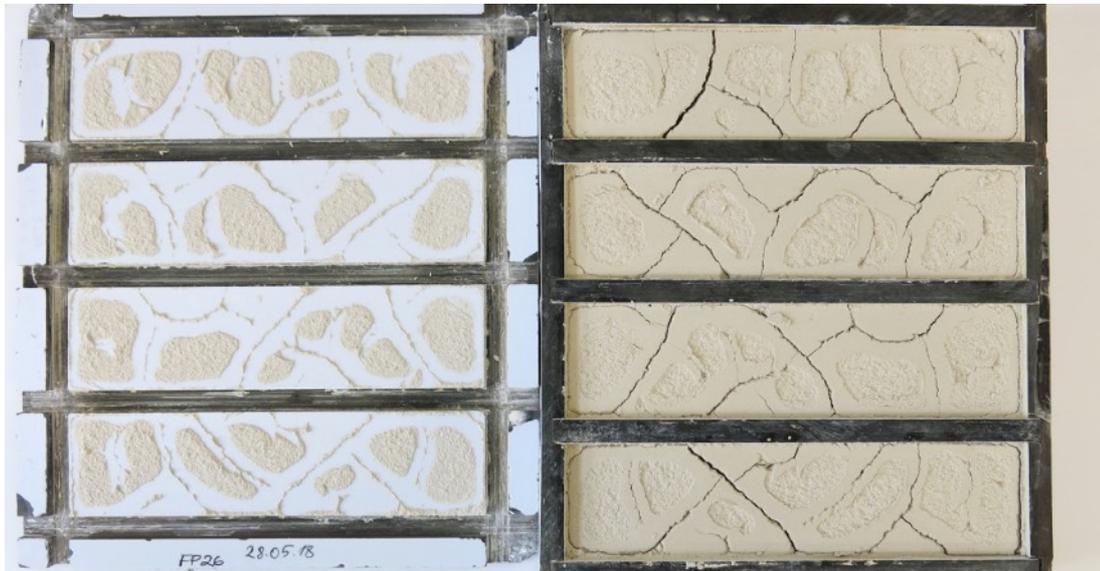
33. Example of the shrinkage cracks which formed in the moulded grouts.

was not possible to remove the samples from the moulds in a single piece. In order to perform the necessary tests, some samples were resized from the larger surviving pieces. This meant that compression strength was measured with the specimens in sizes of 31x35x25 mm, instead of 40x40x40 mm³ as recommended by the European standard.⁶²

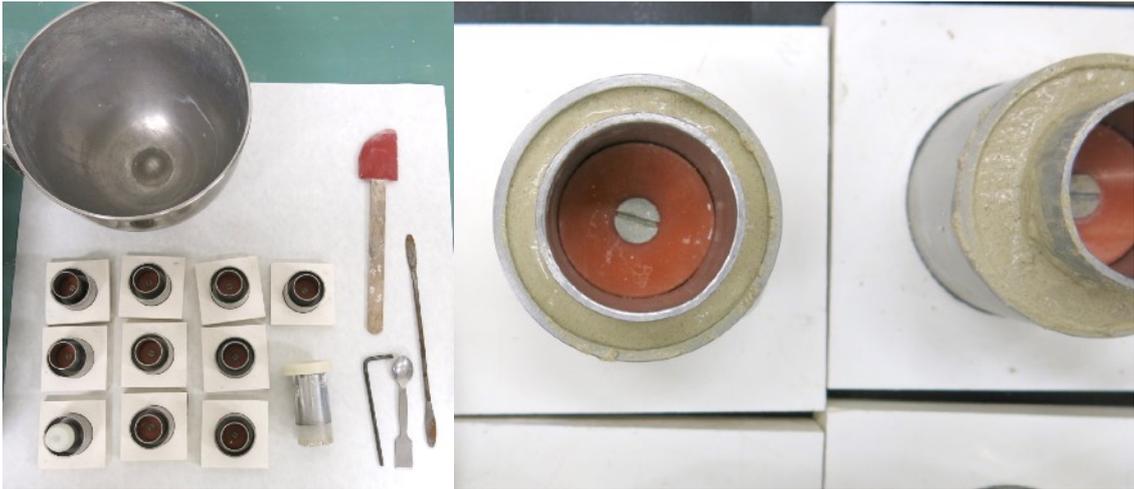
35. Casting of the mortar.

1. Fresh mortar was put in cylinder shaped detachable casts and let to cure for a few days, until the mortar was hardened enough to be removed from the casts (see ill. 35).

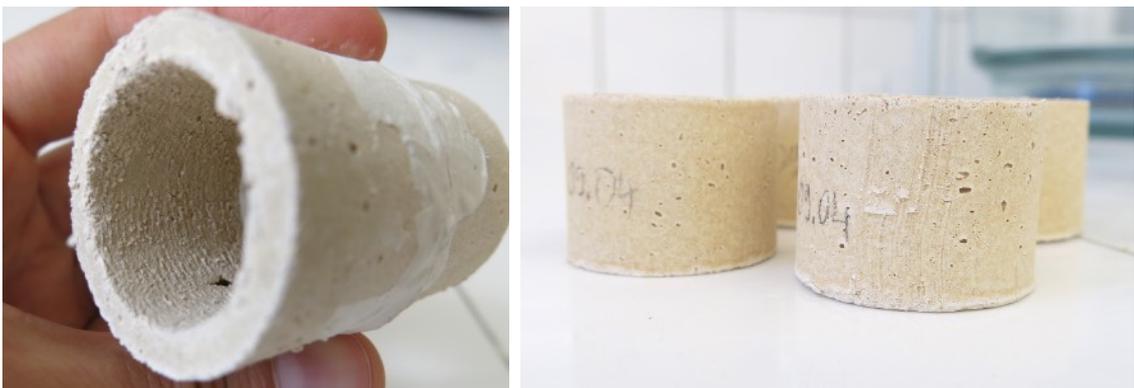
36. Coarsened inner surface and the cured cylinders.

2. The inner surface of the specimen was coarsened before it was taken out of the cast, and left to cure for 28 days. The dimensions of the specimens were 40x40x5 mm (see ill. 36).

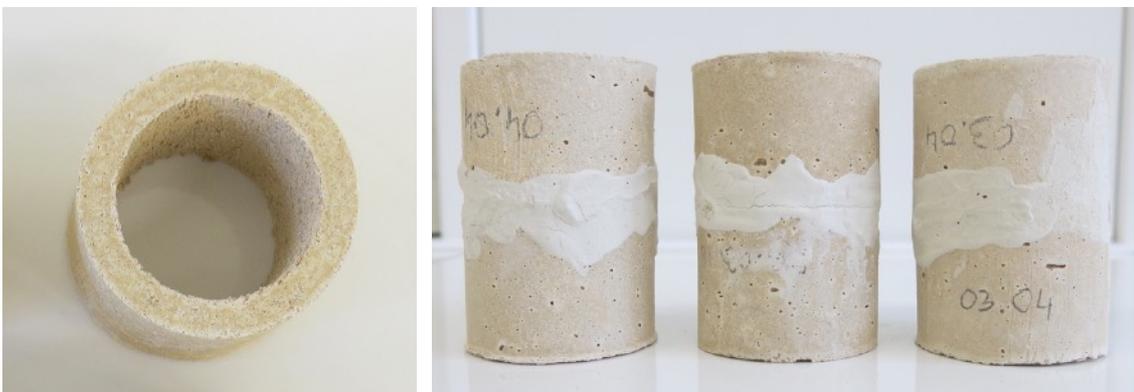
37. Cylinders glued together.

3. Two cylinders were glued together with the mixture of NHL 5 and water (see ill. 37).

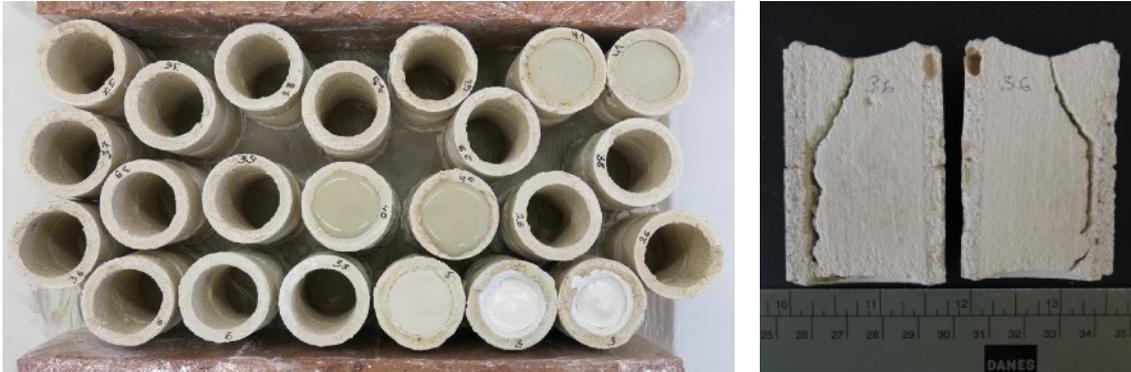
38. Casting the grouts inside the cylinders. The cured grout in the cylinder cut in halves.

- Two cylinders were used for each grout. After 21 days of curing, the specimens were cut in half to evaluate shrinkage (see ill. 38).

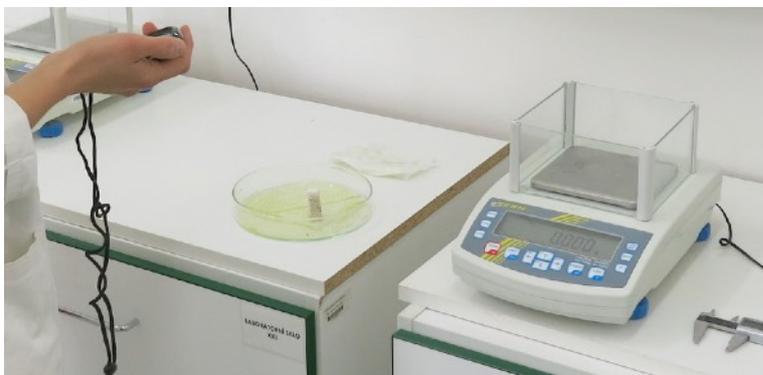
39. Capillary water absorption measurement of a grout sample.

1. The bottom of the 150 mm petri dish was covered with a piece of plastic net to lift the sample above the bottom of the dish.
2. Distilled water was poured in the petri dish, to about 3 mm above the plastic net.
 - The exact level of the water was measured with the plastic calliper.
3. The mass of the sample with dimensions of 15 x 15 x 40 mm was measured, and it was placed vertically on the petri dish with one side in the water.
4. The mass gain of the sample was measured every minute.
 - The maximum duration of the test was 10 minutes. The time of measurements depended on the absorption speed and the size of the sample.
5. Before the sample was put on the scale to measure the gain in weight, the wet side was wiped on moist paper tissue to eliminate extra drips of water.
6. The water absorption coefficient was calculated and recorded.

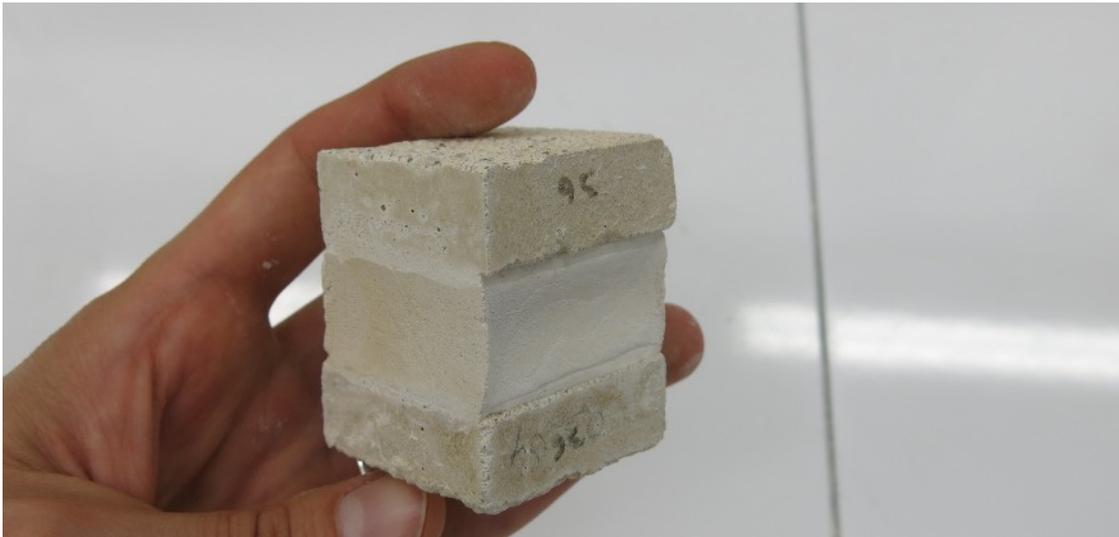
40. Prepared test specimen for the adhesion test. Injection grout between two pieces of imitation mortar.

6. Specimens were stored in air-tight conditions until the measurements were carried out.
7. The adhesion test was performed according to the standard ISO 4624:2016 or ČSN 73 2577. With the measurement device: FPZ100/1, VEB Thuringer Industriewerk, Rauenstein, loading with crosshead speed 2,1-64 mm/min.

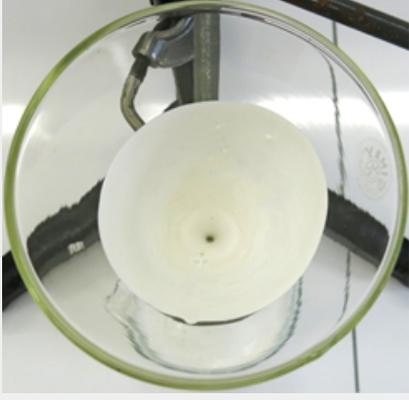
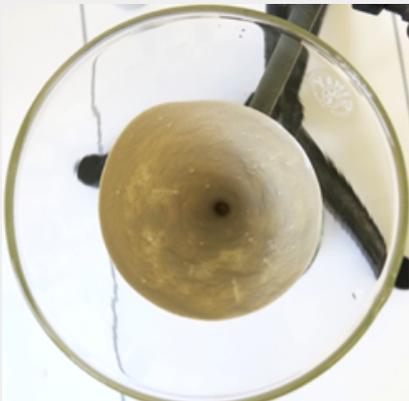
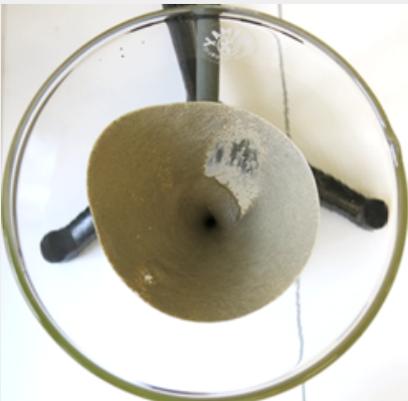
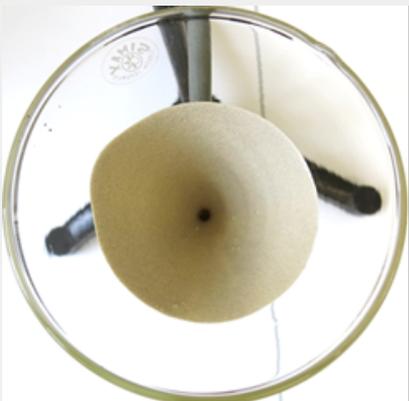
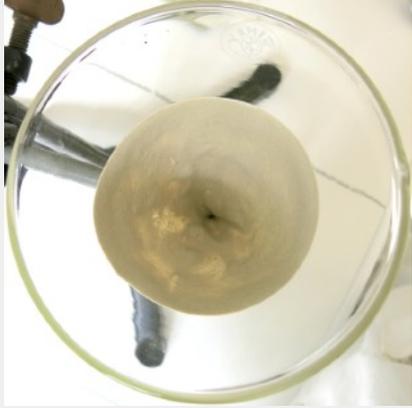
50. Grouts classified as fluid (evaluation mark: 1):

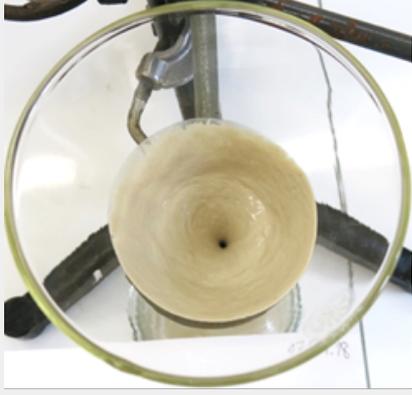
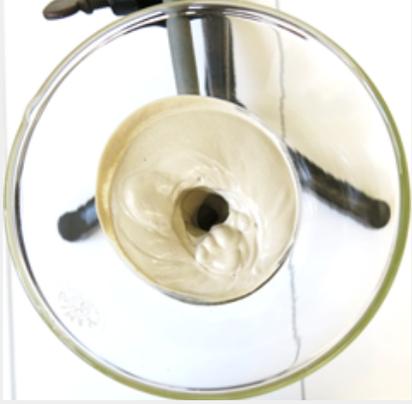
52. Grouts classified as **only dripping** (evaluation mark: 3):

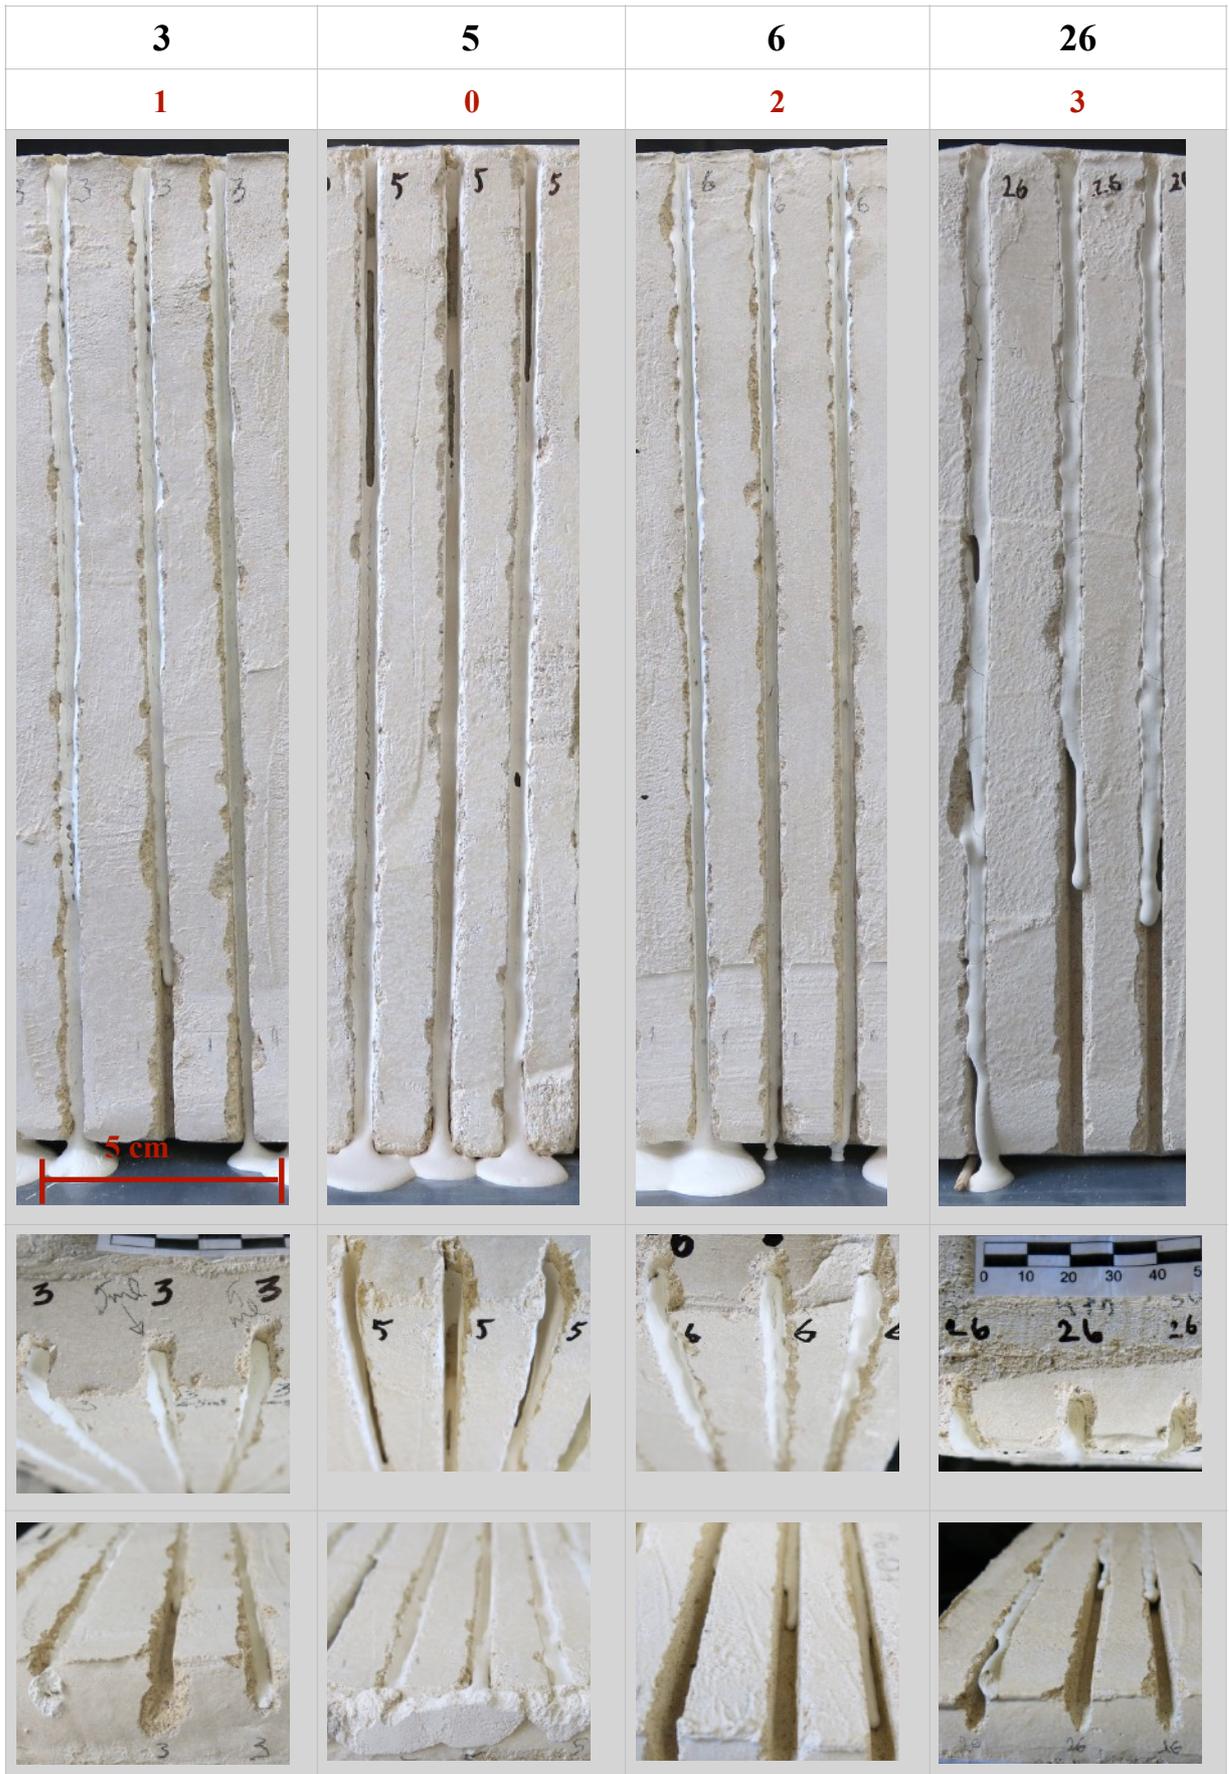
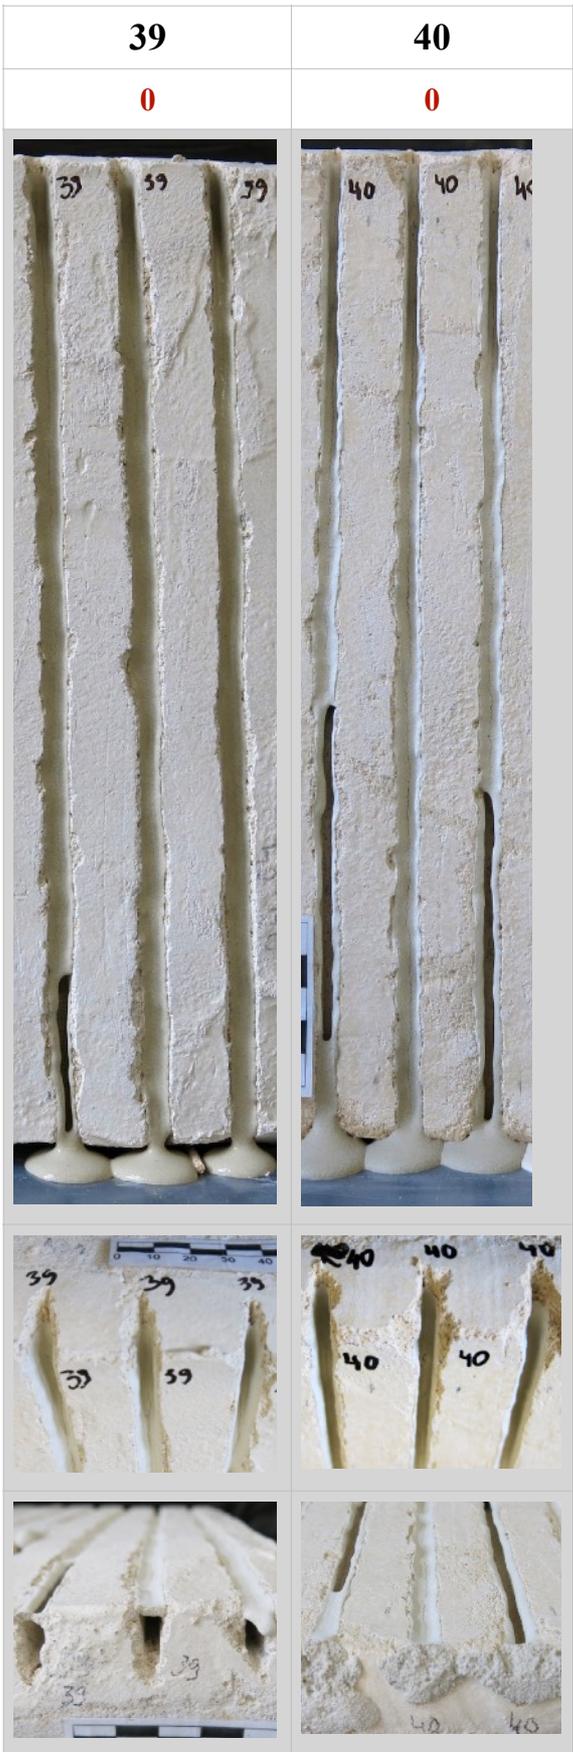
55. Evaluation of the flow on plastered panel test. Evaluation marks are marked with red.

This test was applied to 10 selected grouts, 3 of them commercial, and 7 custom made. Results (see ill. 55) show that the maximum distance of flow (28-28,5 cm) occurred with the commercial grout number 5 and the custom made grouts number 28, 39 and 40, which all contained Tylose MH 300 (5% solution, 25 wt% to binder), K9 (5% solution, 17,8% to binder) and Melment F10 (0,4 wt% to binder).

- The least fluid grout was number 29 (11 cm).
- Modification of the commercial product Ledan TA1 with limestone powder slightly reduced the distance of flow compared to the pure Ledan TA1.
- The use of lightweight fillers Poraver and Liaver reduced the distance of flow due to their lighter weight and coarser filler.

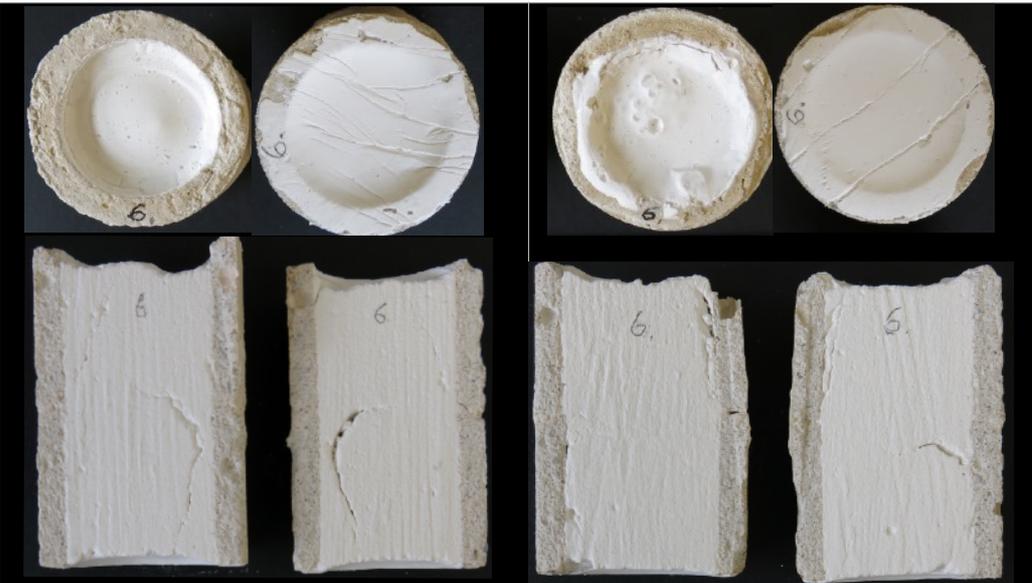
Grouts with evaluation mark no 1		
Grout no 6		Notes

56. Shrinkage in cylinder test. Grouts with the evaluation mark number 1. Specimens are photographed after 21 days of curing, from the top, bottom and when cut in halves. Each grout was tested in two cylinders which are both presented in the table.

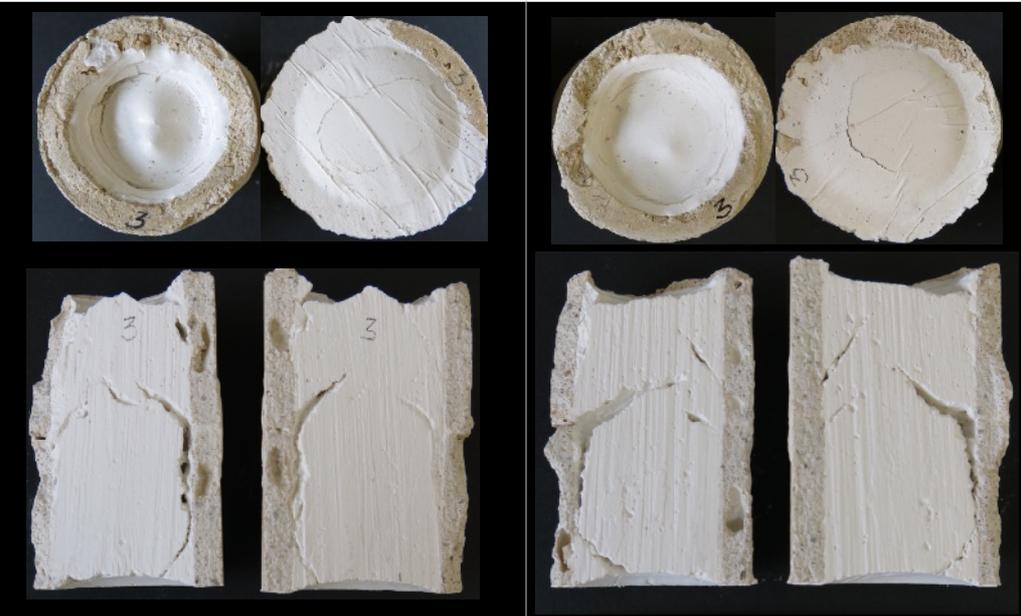
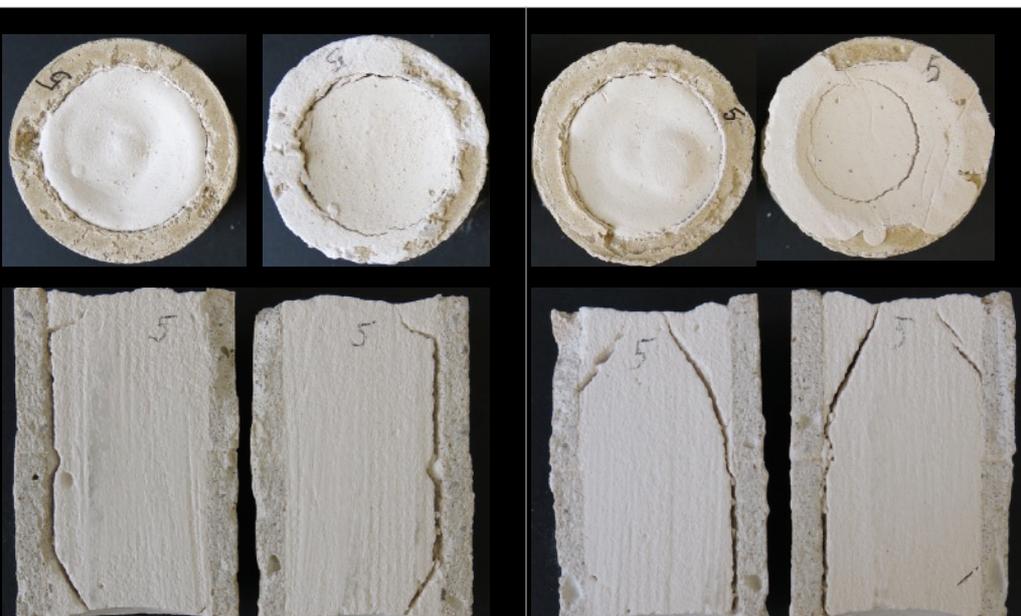
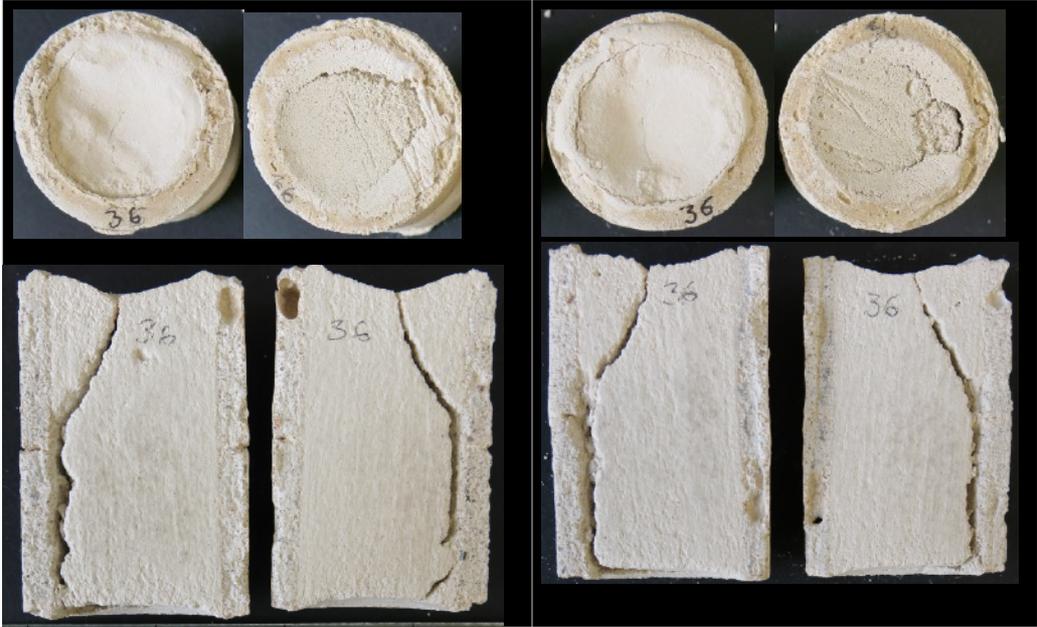
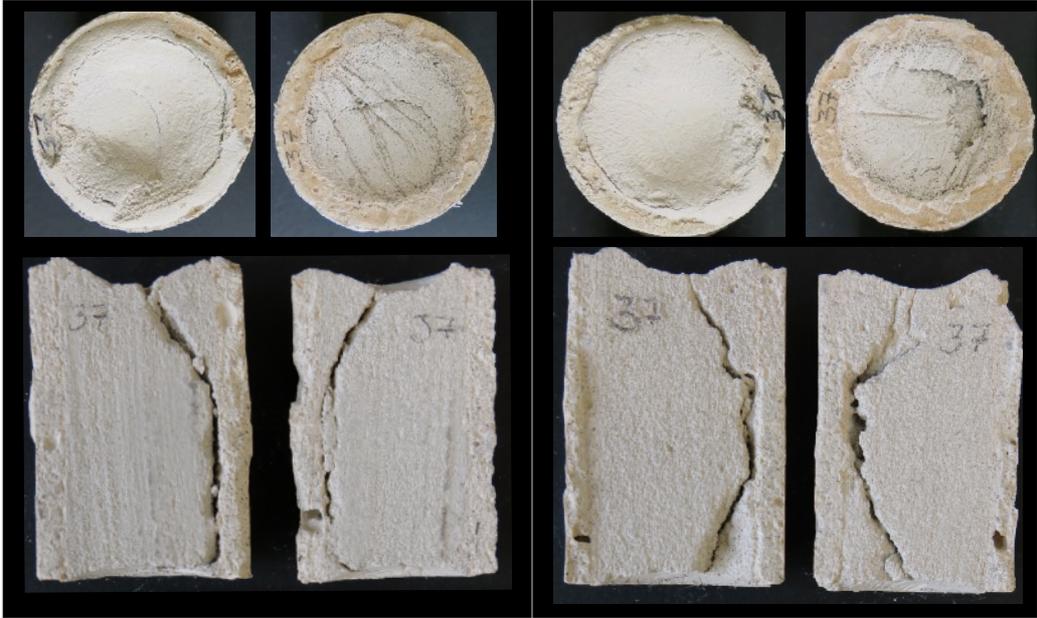
57. Shrinkage in cylinder test. Grouts with the evaluation mark number 2.

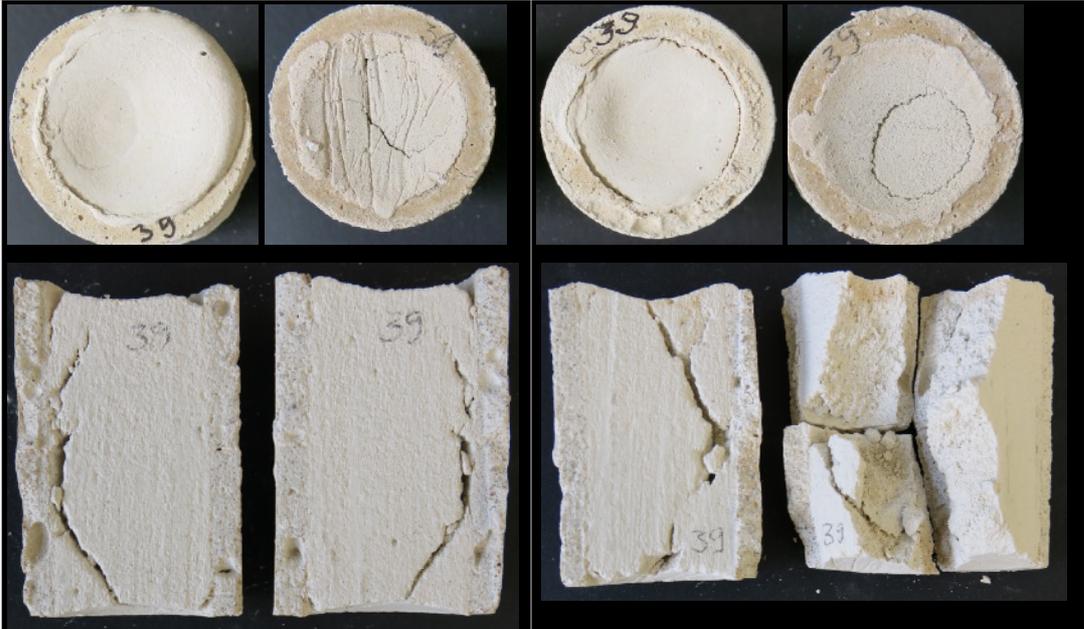
Grout no 39	Notes

<p>The image displays eight photographs of grout specimen 39. The top row shows four top-down views of the specimen, with the number '39' handwritten on the bottom edge of each. The first two images show the specimen in its original state, while the last two show it after being cut in half, revealing a circular internal structure. The bottom row shows four side-view photographs of the specimen, also with '39' handwritten on them. The first two images show the specimen in its original state, and the last two show the broken halves, highlighting the internal texture and the fracture lines.</p>	<p>The specimen broke during cutting it in halves.</p>
Grout no 40	Notes

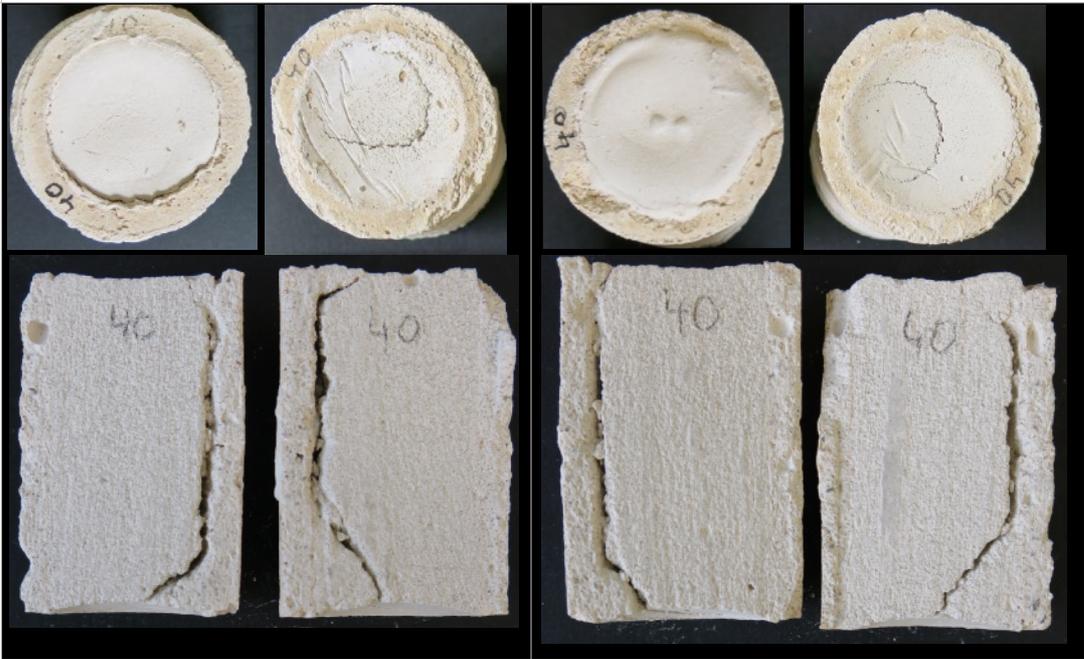
<p>The image displays eight photographs of grout specimen 40. The top row shows four top-down views of the specimen, with the number '40' handwritten on the bottom edge of each. The first two images show the specimen in its original state, while the last two show it after being cut in half, revealing a circular internal structure. The bottom row shows four side-view photographs of the specimen, also with '40' handwritten on them. The first two images show the specimen in its original state, and the last two show the broken halves, highlighting the internal texture and the fracture lines.</p>	<p>-</p>

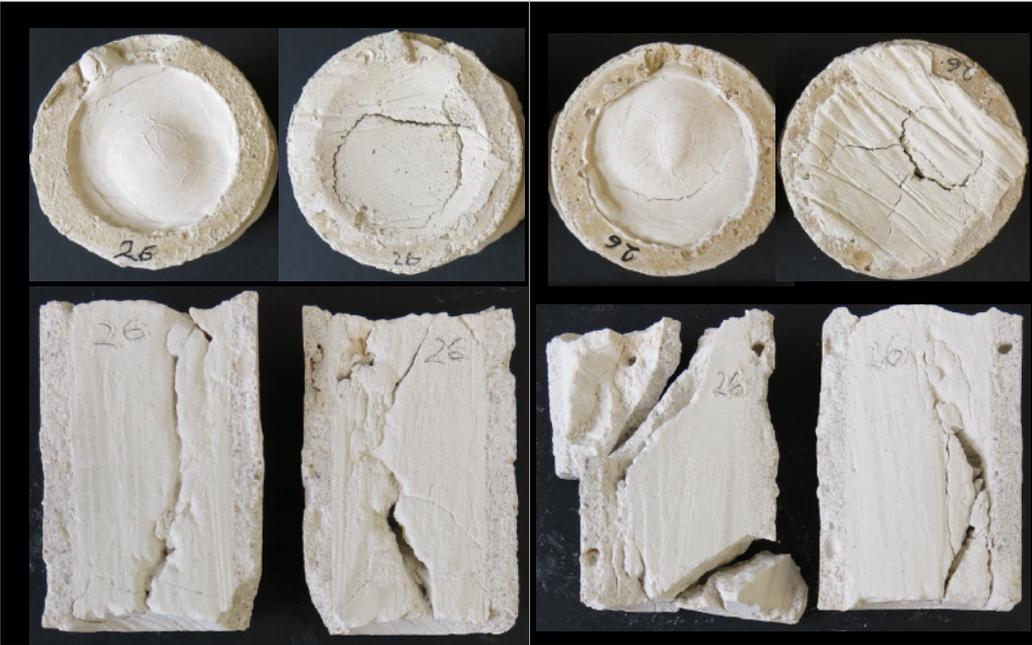
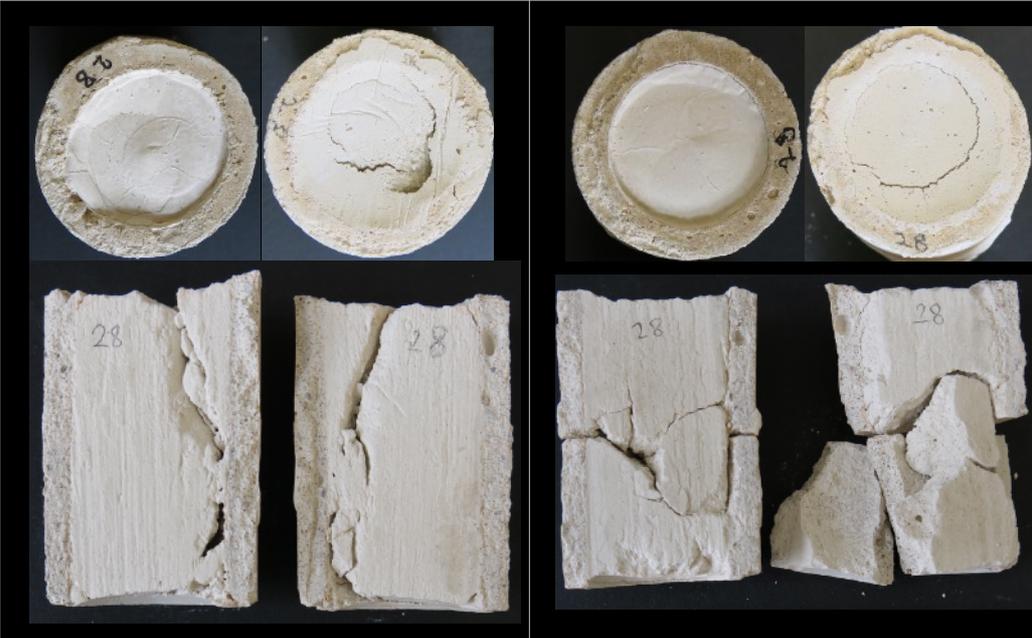
58. Shrinkage in cylinder test. Grouts with the evaluation mark number 3.

Grouts with evaluation mark no 3	
<p style="text-align: center;">Grout no 26</p>

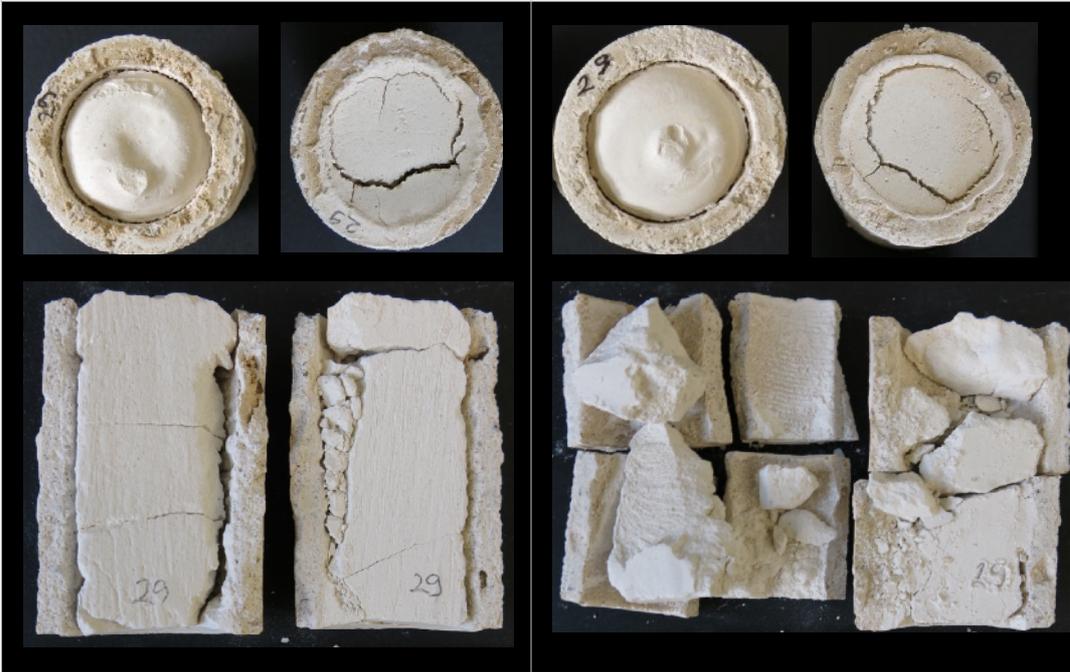
59. Shrinkage in cylinder test. Grouts with the evaluation mark number 4.

<p>One of the specimens broke during cutting it in halves. Gout did not adhere well to the cylinder.</p>

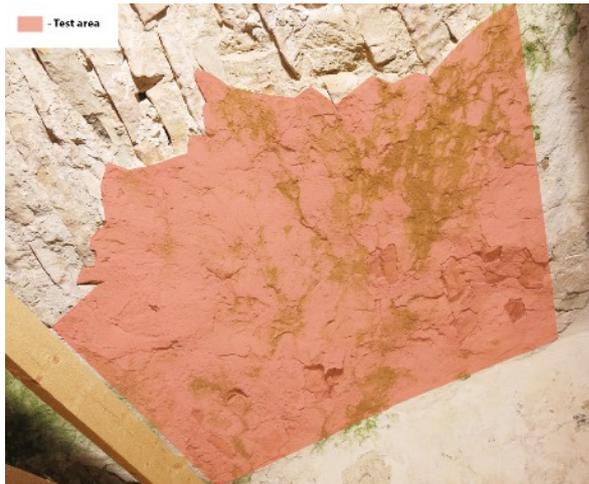
69. The size of the test area is 126x110x124 cm.

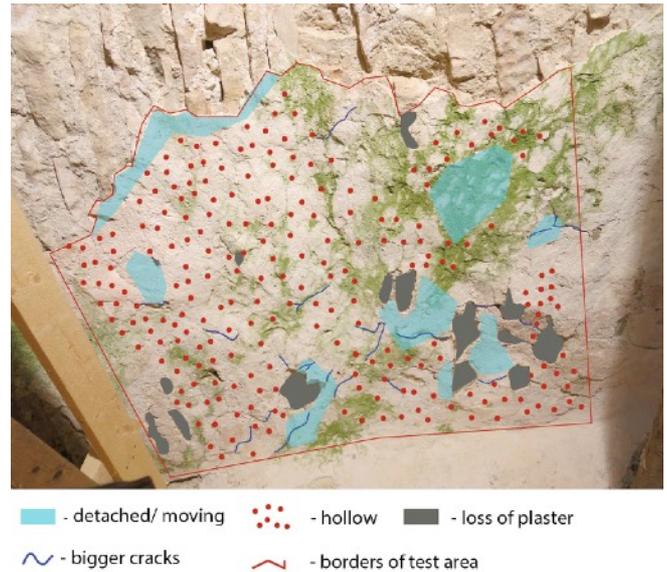
70. The condition mapping of the test area number 1.

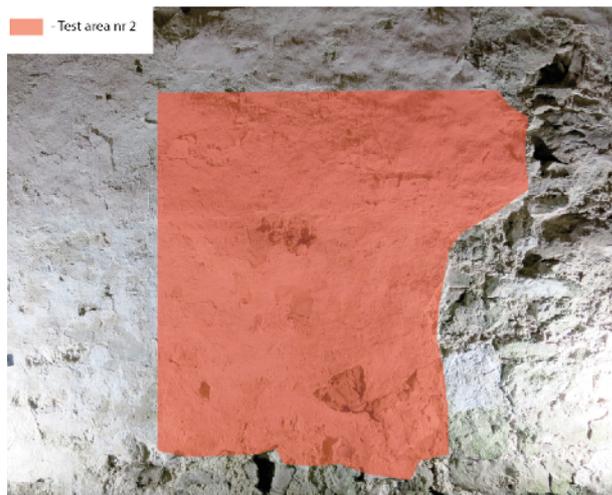
71. The size of the test area is 130x148 cm.

Test area number 2 is located on the lower part of the northern wall. In that area three types of historic plaster were found. First, the plaster from the Gothic construction stage, then the repair mortar, which was applied after the fire in 16th century, and finally the plaster from 17th or 18th century.⁷³ Climate conditions in that area of the wall are poor, since there is excessive moisture in the lower part of the masonry throughout the year.⁷⁴
