ESTONIAN ACADEMY OF ARTS
Faculty of Art and Culture
Department of Cultural Heritage and Conservation

**14TH CENTURY ENGLISH STAINED GLASS PANEL.
ANALYSIS OF THE GLASS DETERIORATION AND
CONSERVATION**

BACHELOR THESIS

Antwerp 2012

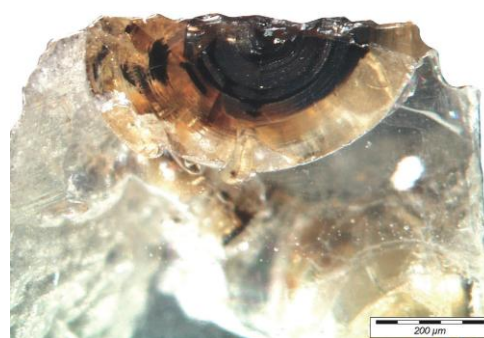
The dark colour that is caused by Mn(IV) is restricted to the leached layers and is never present in the original, unaffected parts of the glass. This can be seen on the images of a cross-section of the samples that were studied for many researches on Mn-staining (Cagno (2011), Schalm (2011), Watkinson (2005), Weber (2005)). For buried archaeological glass, two types of manganese-rich inclusions are distinguishable: dark inclusions in the low-density lamellae of stratified leached layers and in cracks.⁴⁸ (Fig. 8.)

Figure 8. An optical image of a deteriorated region in a cross-sectioned 15th century sample excavated in Raversijd. In this sample, Mn-rich inclusions can be found between the lamellae of the stratified leached layer.

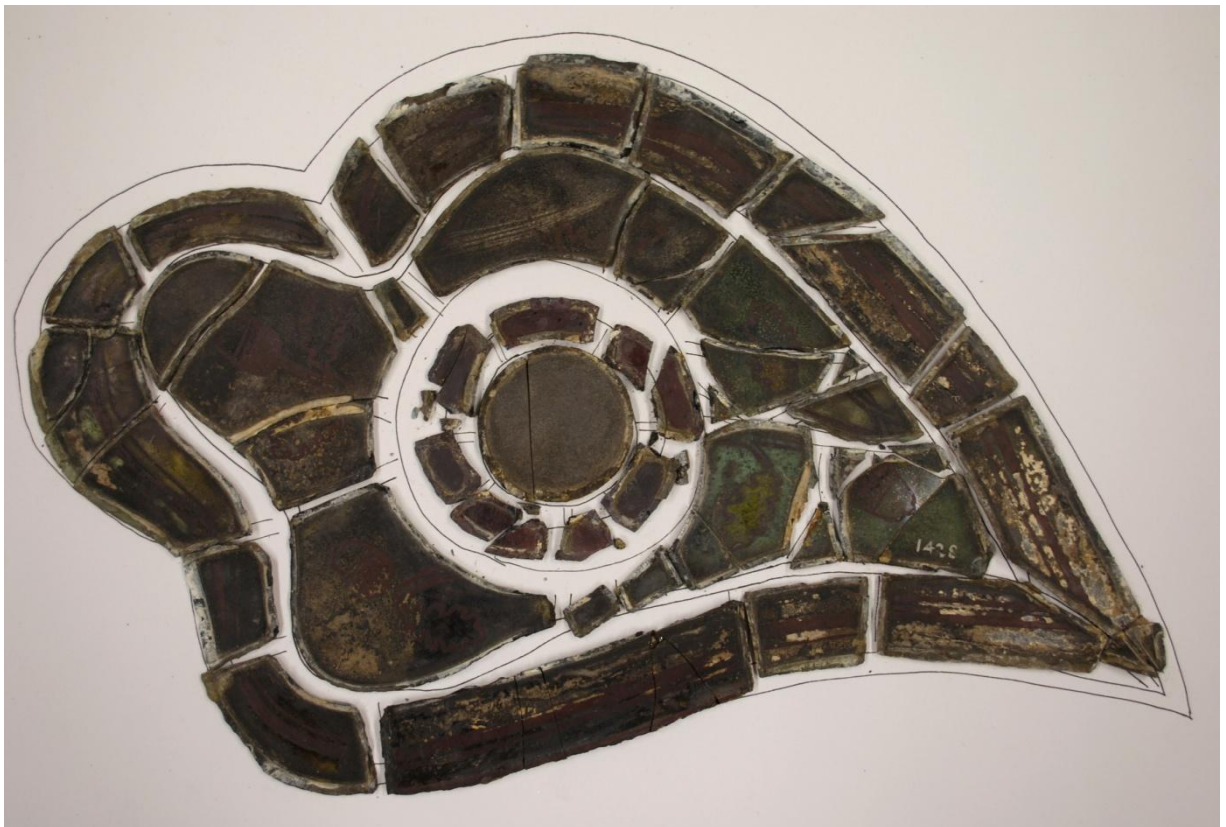
Figure 18. Dismantled panel.

Dismantling (Fig. 16.) of the panel showed that it was cemented. One of the leads used to repair the piece nr 12 didn't have a core. Lead supporting crack in the piece nr 10 was heavily cemented to stay in place. After dismantling edges of the glass pieces can be seen that they show evident signs of use of the riesel iron (Fig. 17.).

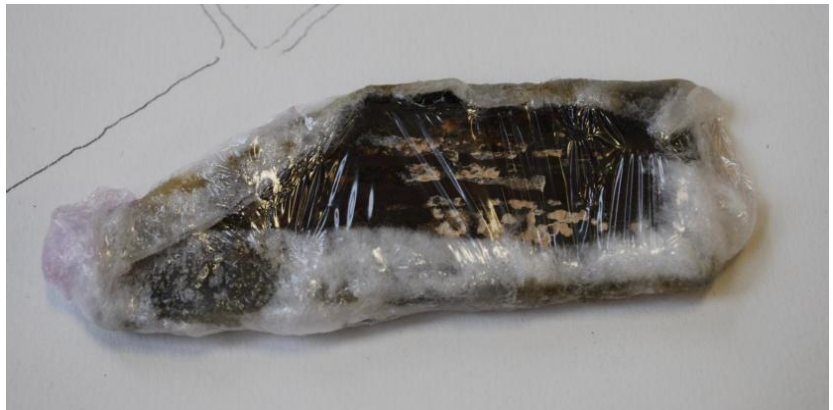
Figure 19. Piece in a DMF wrap.

The edges of the each piece were covered with cotton compress with DMF and wrapped in plastic to prevent the solution from evaporating. It was left like that for an hour to let the solution work (Fig 19.). After an hour the piece was taken out of the wrap and the softened cement was removed with a scalpel (Fig. 20.).

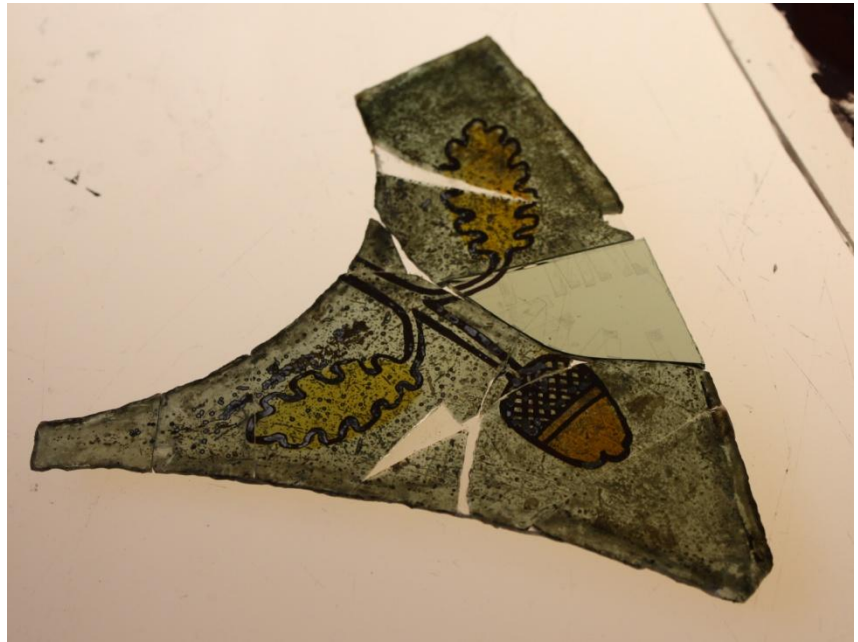
Figure 23. Making the infill.

Missing fragment was cut out from the glass with as similar shade to original as possible. Colouring of the fragment was done using grisaille paints and later fixated by baking in the oven.

New infill was bonded with the rest of the piece using Araldite 2020. As a final step of reconstruction the transparent parts that were created by epoxy were covered with retouch.

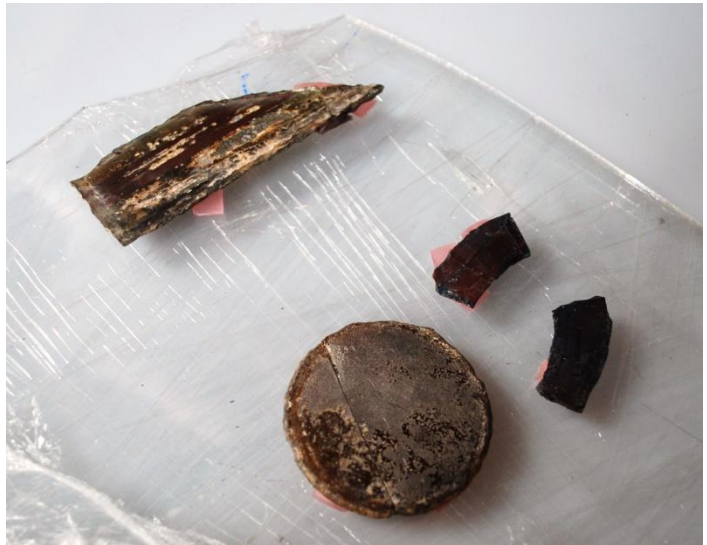
Figure 25. Bonding the pieces.

Pieces were **bonded** with the epoxy Araldite 2020. Edges of the fragments were cleaned thoroughly with acetone and fixed in place with a transparent scotch tape. Pieces were placed on a glass wrapped in plastic, to insure that the pieces are not going to be stuck to the base, pieces of dental wax were placed in between (Figure 25.). After the curing period of 24 hours the scotch tape and the excess of the glue was gently removed with the scalpel.

The lead strap was left to support pieces no. 1, 3, 8, 10 and 13.

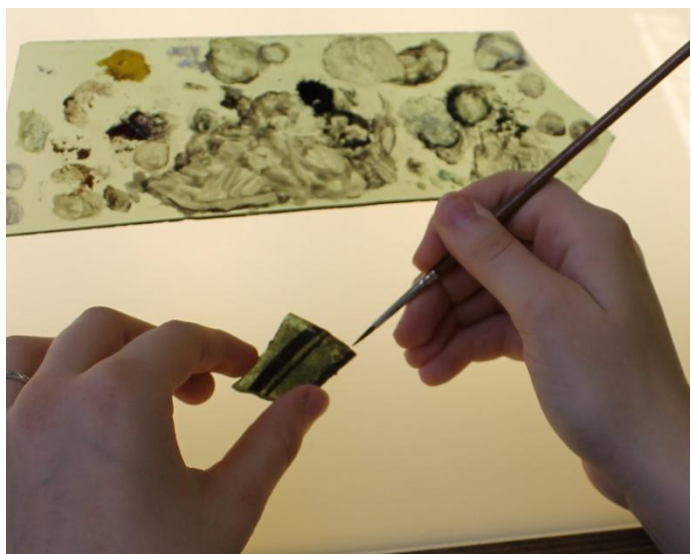
Figure 26. Retouching.

After bonding pieces had to be **retouched**. For that was used inorganic pigments with Paraloid B72. dissolved in diacetonealcohol. Retouches covered transparent parts that were created with bonding.

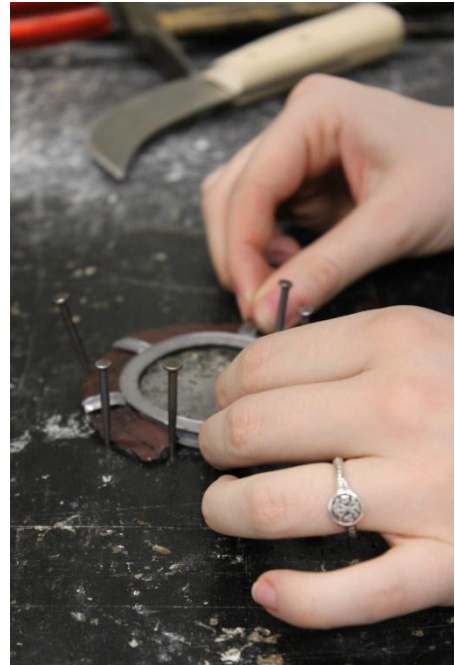
Figure 27. Securing the glass with nails before soldering.

Leading was done by using 5 mm, 8 mm and 10 mm lead. Pieces put together with lead and secured in place with nails. After reassembling the edges of the lead were pushed down to make soldering more efficient. Meeting points of the lead were soldered with soldering iron. To solder the lead with tin it is necessary to use an oliena, which prevents oxidation of the metal during the soldering process.

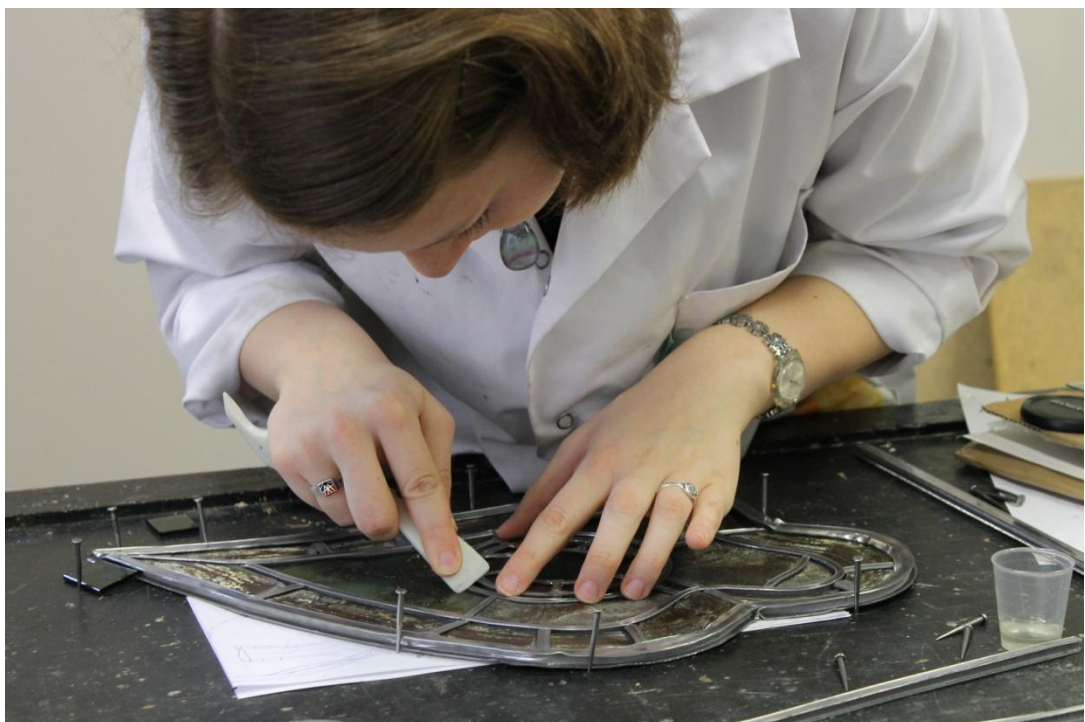
Figure 28. Pushing down the edges of the lead.

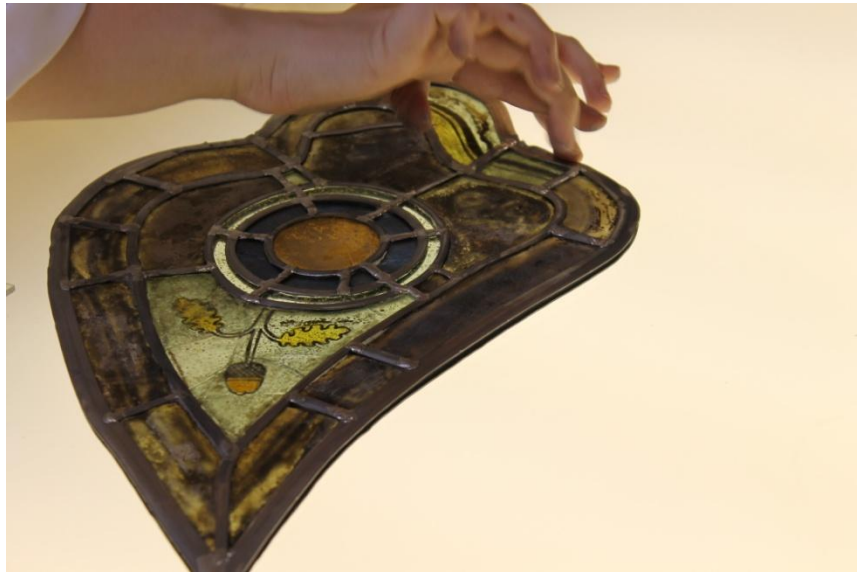
Figure 29. Cementing the panel.

After the panel was soldered it could be seen that there were still some gaps between the glass and the lead. To fill the gaps was used a cement. It was made by mixing powdered chalk and linen seed oil. In order to camouflage the cement and make it grey as lead, little amount of black pigment was added. Cement was applied with fingers as it gave the full control of the process and minimized the unnecessary impact with the panel. Leftovers of cement were removed with water ethanol 50/50 solution.

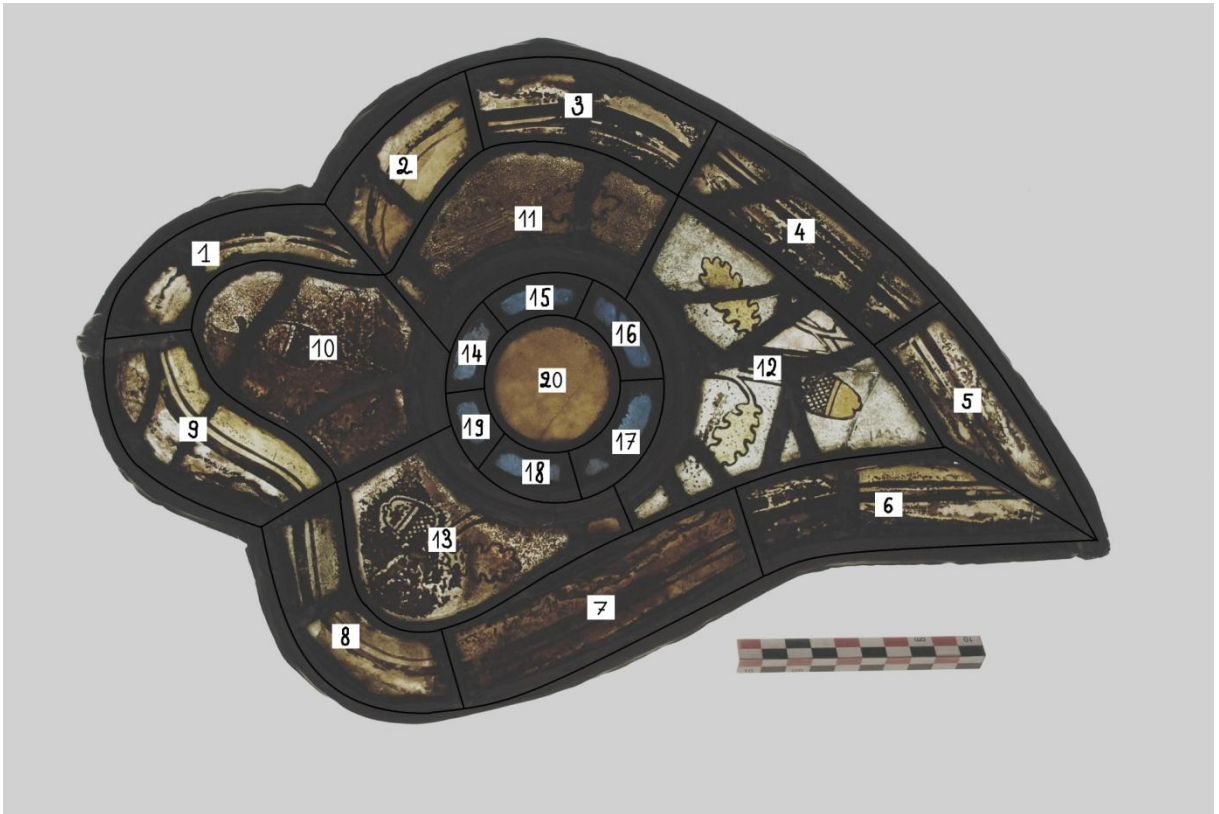
Next section depicts four acorns each with a stem and two leaves on a white glass. Acorn and its leaves that is closer to the tail is coloured with silver stain. All the acorns are facing away from the middle part. In the piece no. 12⁶⁴, there is one piece of glass that is mismatching the rest of the pattern. As the colour and thickness of the glass is different from the rest of the panel it is possible that the whole fragment no. 12 is added later.

The external part has two border lines – one heavy another light. During last re-leading of the panel, two pieces (no. 4 and no. 7) have been installed upside down.

Figure 5. Division and numbering of the panel.
